# Access Compliance Report

## Public Rights-of-Way

### (Curb Ramps)

Intersection ID: 10027409	Main Street: GOLF_ACRES_DR	Cross Street: N/A	Location: NE
ADA ID: F00E5A850C25	Ramp Type: Combination2Diag	Initial Pass/Fail: Fail	Overall Compliance: No
		Severity Score: 0

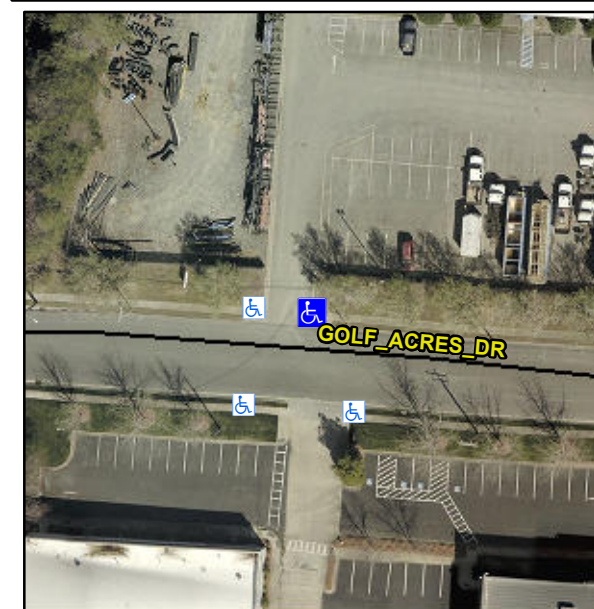
**Not Found, R304.5.1, R304.5.3, R304.3.2**

Compliance	Description	Data	Compliance	Description	Data
N/A	Ramp Length LT (in)	49.0	N/A	Ramp Length RT (in)	N/A
Yes	Ramp Width LT (in)	87.0	N/A	Ramp Width RT (in)	N/A
No	Ramp Slope LT (%)	10.8	N/A	Ramp Slope RT (%)	N/A
Yes	Ramp XSlope LT (%)	0.2	N/A	Ramp XSlope RT (%)	N/A
N/A	Ramp Length (in)	36.0	Yes	Ramp Slope (%)	6.4
No	Ramp Width (in)	46.5	No	Ramp XSlope (%)	5.7
N/A	Flare Type LT	N/A	N/A	Flare Type RT	N/A
N/A	Flare Slope LT (%)	N/A	N/A	Flare Slope RT (%)	N/A
N/A	Flare Traversable LT?	N/A	N/A	Flare Traversable RT?	N/A
N/A	Landing Length (in)	N/A	N/A	DWS Provided?	N/A
N/A	Landing Width (in)	N/A	N/A	DWS Contrast?	N/A
N/A	Landing Slope (%)	N/A	N/A	DWS Length (in)	N/A
N/A	Landing X Slope (%)	N/A	N/A	DWS Full Width?	N/A
N/A	Landing Curb? (Y/N)	N/A	N/A	DWS Offset (in)	N/A
N/A	Shared Landing?	N/A			
N/A	Gutter Ponding?	N/A	N/A	Gutter Slope (%)	N/A
N/A	Gutter Lip Ht (in)	N/A	N/A	Gutter X Slope (%)	N/A
N/A	Painted X Walk1?	No	N/A	Painted X Walk2?	No

**Remove & Replace Curb Ramp With Two New Directional Ramps or Equivalent.**
