Access Compliance Report

Public Rights-of-Way

(Curb Ramps)

Intersection ID: 50042	Main Street: METROPOLITAN_AV	Cross Street: S_KINGS_DR	Location: SE
ADA ID: F02DD45E742B	Ramp Type: Combination1	Initial Pass/Fail: Fail	Overall Compliance: No
			Severity Score: 33.75

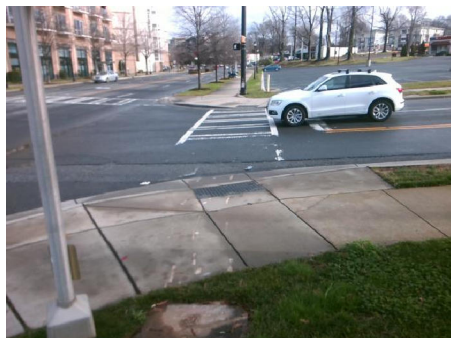
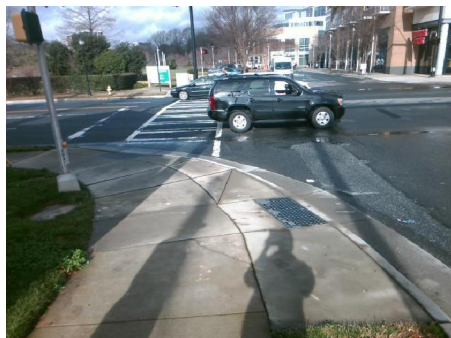
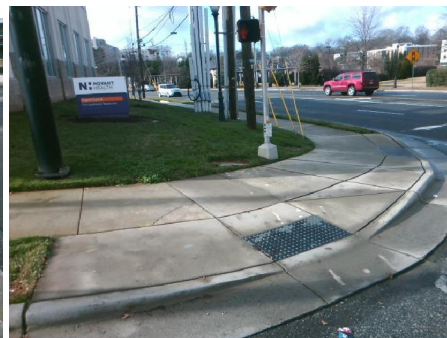
Not Found, R304.5.1, R304.5.3

Compliance	Description	Data	Compliance	Description	Data
N/A	Ramp Length LT (in)	48.0	N/A	Ramp Length RT (in)	42.0
Yes	Ramp Width LT (in)	71.0	Yes	Ramp Width RT (in)	71.0
Yes	Ramp Slope LT (%)	7.7	Yes	Ramp Slope RT (%)	6.0
Yes	Ramp XSlope LT (%)	0.9	No	Ramp XSlope RT (%)	4.8
N/A	Ramp Length (in)	48.0	Yes	Ramp Slope (%)	6.9
No	Ramp Width (in)	46.0	No	Ramp XSlope (%)	7.0
N/A	Flare Type LT	N/A	N/A	Flare Type RT	N/A
N/A	Flare Slope LT (%)	N/A	N/A	Flare Slope RT (%)	N/A
N/A	Flare Traversable LT?	N/A	N/A	Flare Traversable RT?	N/A
N/A	Landing Length (in)	N/A	N/A	DWS Provided?	N/A
N/A	Landing Width (in)	N/A	N/A	DWS Contrast?	N/A
N/A	Landing Slope (%)	N/A	N/A	DWS Length (in)	N/A
N/A	Landing X Slope (%)	N/A	N/A	DWS Full Width?	N/A
N/A	Landing Curb? (Y/N)	N/A	N/A	DWS Offset (in)	N/A
N/A	Shared Landing?	N/A			
N/A	Gutter Ponding?	N/A	N/A	Gutter Slope (%)	N/A
N/A	Gutter Lip Ht (in)	N/A	N/A	Gutter X Slope (%)	N/A
N/A	Painted X Walk1?	Yes	N/A	Painted X Walk2?	N/A

X Walk 1 Direction	To NE		X Walk 2 Direction	N/A
	X Walk 1 Width (in)	108.0		X Walk 2 Width (in)	N/A
	X Walk 1 Slope (%)	3.4		X Walk 2 Slope (%)	N/A
	X Walk 1 X Slope (%)	4.5		X Walk 2 X Slope (%)	N/A
N/A	Ramp inside XWalk1?	Yes	N/A	Ramp inside XWalk2?	N/A
	Road Slope (%)	N/A		Clear Space?	N/A
	Road X Slope (%)	N/A	N/A	Clear Space to XWalk (in)	N/A
			N/A	Any Obstruction?	N/A
				Obstruction Type	N/A
			N/A	Storm Grate/Utility Hazard?	N/A
				Storm Grate/Utility Type	N/A
Yes	Surface Condition? (G/P)	Good			
	Curb Slope (%)	13.1

Remove & Replace Entire Ramp.
