## Access Compliance Report Public Rights-of-Way (Curb Ramps)

Intersection ID: 16535Main Street: ELDER\_AVCross Street: ROSS\_MOORE\_AVLocation:SADA ID: F02F6A3A58C1Ramp Type: BlendTrans1Initial Pass/Fail: FailOverall Compliance: NoSeverity Score: 17.5

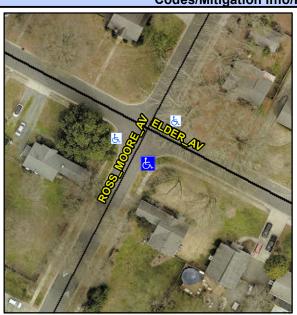
Not Found, R304.5.1

| Field Measurements/Component Comphance | | | | | | |
|--|---|---|---|---|---|---|
| | No | Ramp Width (in) | 35.5 | Yes | BlendTrans XSlope (%) | 1.3 |

ELDER AV None ROSS MOORE AV StopSign Possible Solutions:

Remove & Replace Curb Ramp With Two New Directional Ramps or Equivalent.
