# Access Compliance Report

## Public Rights-of-Way

### (Curb Ramps)

Intersection ID: 10030604	Main Street: LOMA_LINDA_LN	Cross Street: N/A	Location: E
ADA ID: F067B7CC6576	Ramp Type: Perp	Initial Pass/Fail: Fail	Overall Compliance: No
Severity Score: 12.5			
Codes/Mitigation Info/Possible Solution		Field Measurements/Component Compliance

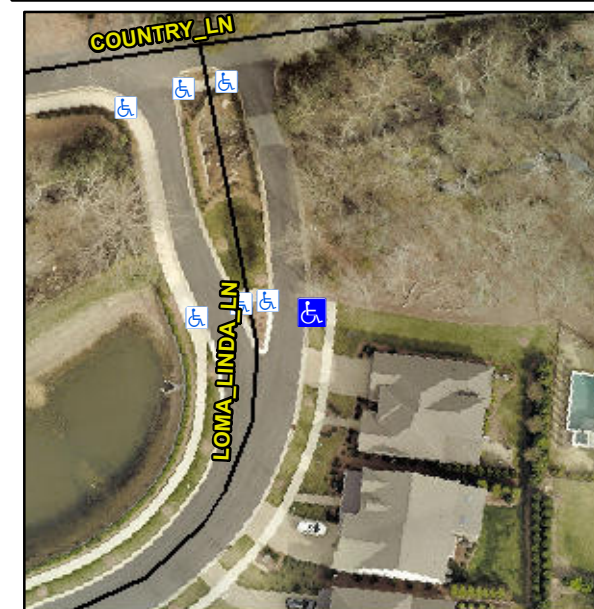
**Not Found, R304.5.3**

Compliance	Description	Data	Compliance	Description	Data
N/A	Ramp Length (in)	102.0	Yes	Ramp Slope (%)	7.9
Yes	Ramp Width (in)	69.0	No	Ramp XSlope (%)	5.2
N/A	Flare Type LT	N/A	N/A	Flare Type RT	N/A
N/A	Flare Slope LT (%)	N/A	N/A	Flare Slope RT (%)	N/A
N/A	Flare Traversable LT?	N/A	N/A	Flare Traversable RT?	N/A
N/A	Landing Length (in)	N/A	N/A	DWS Provided?	N/A
N/A	Landing Width (in)	N/A	N/A	DWS Contrast?	N/A
N/A	Landing Slope (%)	N/A	N/A	DWS Length (in)	N/A
N/A	Landing X Slope (%)	N/A	N/A	DWS Full Width?	N/A
N/A	Landing Curb? (Y/N)	N/A	N/A	DWS Offset (in)	N/A
N/A	Shared Landing?	N/A			
N/A	Gutter Ponding?	N/A	N/A	Gutter Slope (%)	N/A
N/A	Gutter Lip Ht (in)	N/A	N/A	Gutter X Slope (%)	N/A
N/A	Painted X Walk1?	No	N/A	Painted X Walk2?	N/A
	X Walk 1 Direction	To W		X Walk 2 Direction	N/A
N/A	X Walk 1 Width (in)	N/A	N/A	X Walk 2 Width (in)	N/A
	X Walk 1 Slope (%)	3.6		X Walk 2 Slope (%)	N/A
	X Walk 1 X Slope (%)	3.4		X Walk 2 X Slope (%)	N/A

**Remove & Replace Entire Ramp.**
