Access Compliance Report Public Rights-of-Way (Curb Ramps)

Intersection ID: 16453 Main Street: MARVIN_RD Cross Street: N_WENDOVER_RD Location: ADA ID: F07EF36F9B42 Ramp Type: PerpDiag Initial Pass/Fail: Fail **Overall Compliance: No** Severity Score: 13.75

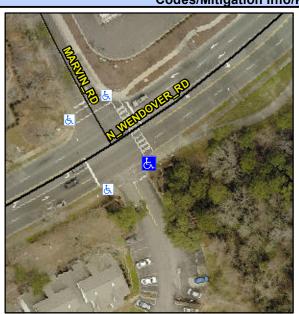
Field Measurements/Component Compliance					
Compliance Description		Data	Comp	oliance Description	Data
N/A	Ramp Length (in)	69.0	No	Ramp Slope (%)	8.4
Yes	Ramp Width (in)	96.0	No	Ramp XSlope (%)	4.5
N/A	Flare Type LT	N/A	N/A	Flare Type RT	N/A
N/A	Flare Slope LT (%)	N/A	N/A	Flare Slope RT (%)	N/A
N/A	Flare Traversable LT?	N/A	N/A	Flare Traversable RT?	N/A
N/A	Landing Length (in)	N/A	N/A	DWS Provided?	N/A
N/A	Landing Width (in)	N/A	N/A	DWS Contrast?	N/A
N/A	Landing Slope (%)	N/A	N/A	DWS Length (in)	N/A
N/A	Landing X Slope (%)	N/A	N/A	DWS Full Width?	N/A
N/A	Landing Curb? (Y/N)	N/A	N/A	DWS Offset (in)	N/A
N/A	Shared Landing?	N/A			
N/A	Gutter Ponding?	N/A	N/A	Gutter Slope (%)	N/A
N/A	Gutter Lip Ht (in)	N/A	N/A	Gutter X Slope (%)	N/A
N/A	Painted X Walk1?	Yes	N/A	Painted X Walk2?	Yes
	X Walk 1 Direction	To NW		X Walk 2 Direction	To SW
N/A	X Walk 1 Width (in)	120.0	N/A	X Walk 2 Width (in)	105.0
	X Walk 1 Slope (%)	2.4		X Walk 2 Slope (%)	3.8

X Walk 1 X Slope (%)	0.7		X Walk 2 X Slope (%)	1.9
N/A	Ramp inside XWalk1?	Yes	N/A	Ramp inside XWalk2?	Yes
	Road Slope (%)	2.1	N/A	Clear Space?	N/A
	Road X Slope (%)	3.5	N/A	Clear Space to XWalk (in)	N/A
N/A	Any Obstructions?	N/A	N/A	Storm Grate/Utility Hazard?	N/A
	Obstruction Type			Storm Grate/Utility Type	
		N/A			N/A
			Yes	Surface Condition? (G/P)	Good
Maria de la compansión de		·	-

Possible Solutions: Remove & Replace Curb Ramp With **Two New Directional Ramps or** Equivalent. Surveyor Notes: N/A PROW/ADA: Not Found, R304.2.2, R304.5.3
