# Access Compliance Report

## Public Rights-of-Way

### (Curb Ramps)

Intersection ID: N/A	Main Street: STATESVILLE_AV	Cross Street: BADGER_CT	Location: SW
ADA ID: F0DB4509827E	Ramp Type: Combination2Diag	Initial Pass/Fail: Fail	Overall Compliance: No
Severity Score: 0			
Codes/Mitigation Info/Possible Solution		Field Measurements/Component Compliance

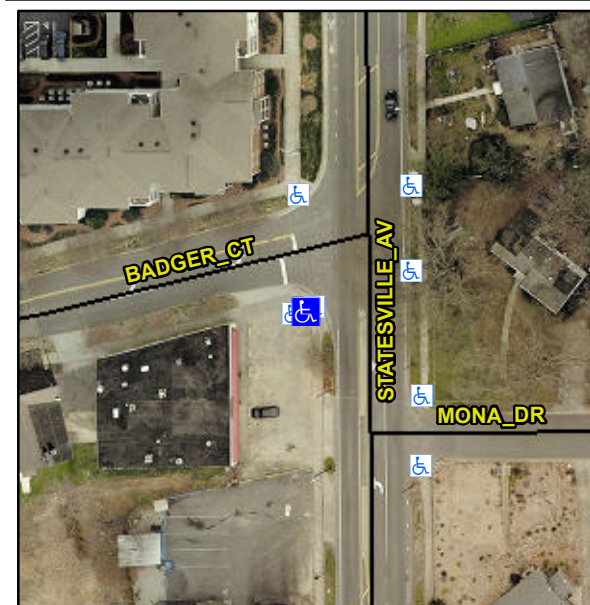
**Not Found, R304.5.1, R304.5.3**

Compliance	Description	Data	Compliance	Description	Data
N/A	Ramp Length LT (in)	42.0	N/A	Ramp Length RT (in)	40.0
Yes	Ramp Width LT (in)	48.0	Yes	Ramp Width RT (in)	48.0
Yes	Ramp Slope LT (%)	6.1	Yes	Ramp Slope RT (%)	2.3
Yes	Ramp XSlope LT (%)	1.1	Yes	Ramp XSlope RT (%)	0.6
N/A	Ramp Length (in)	25.0	Yes	Ramp Slope (%)	6.3
No	Ramp Width (in)	47.5	No	Ramp XSlope (%)	4.6
N/A	Flare Type LT	N/A	N/A	Flare Type RT	N/A
N/A	Flare Slope LT (%)	N/A	N/A	Flare Slope RT (%)	N/A
N/A	Flare Traversable LT?	N/A	N/A	Flare Traversable RT?	N/A
N/A	Landing Length (in)	N/A	N/A	DWS Provided?	N/A
N/A	Landing Width (in)	N/A	N/A	DWS Contrast?	N/A
N/A	Landing Slope (%)	N/A	N/A	DWS Length (in)	N/A
N/A	Landing X Slope (%)	N/A	N/A	DWS Full Width?	N/A
N/A	Landing Curb? (Y/N)	N/A	N/A	DWS Offset (in)	N/A
N/A	Shared Landing?	N/A			
N/A	Gutter Ponding?	N/A	N/A	Gutter Slope (%)	N/A
N/A	Gutter Lip Ht (in)	N/A	N/A	Gutter X Slope (%)	N/A
N/A	Painted X Walk1?	No	N/A	Painted X Walk2?	No

X Walk 1 Direction	To E		X Walk 2 Direction	To N
	X Walk 1 Width (in)	N/A		X Walk 2 Width (in)	N/A
	X Walk 1 Slope (%)	6.0		X Walk 2 Slope (%)	1.8
	X Walk 1 X Slope (%)	0.5		X Walk 2 X Slope (%)	5.0
N/A	Ramp inside XWalk1?	N/A	N/A	Ramp inside XWalk2?	N/A
	Road Slope (%)	3.6		Clear Space?	N/A
	Road X Slope (%)	3.8	N/A	Clear Space to XWalk (in)	N/A
			N/A	Any Obstruction?	N/A
				Obstruction Type	N/A
			N/A	Storm Grate/Utility Hazard?	N/A
				Storm Grate/Utility Type	N/A
Yes	Surface Condition? (G/P)	Good			
	Curb Slope (%)	22.9

**Remove & Replace Curb Ramp With Two New Directional Ramps or Equivalent.**
