Access Compliance Report

Public Rights-of-Way

(Curb Ramps)

Intersection ID: 45172	Main Street: ELDON_DR	Cross Street: LINDEN_TREE_LN	Location: SW
ADA ID: F0E353ED13DA	Ramp Type: Perp	Initial Pass/Fail: Fail	Overall Compliance: No
Severity Score: 37.5			
Codes/Mitigation Info/Possible Solution		Field Measurements/Component Compliance

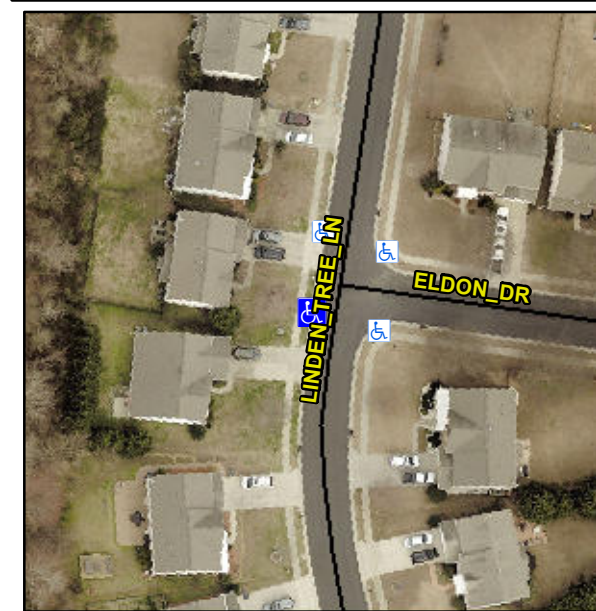
Not Found, R304.2.2, R304.5.3

Compliance	Description	Data	Compliance	Description	Data
N/A	Ramp Length (in)	47.0	No	Ramp Slope (%)	14.5
Yes	Ramp Width (in)	60.0	No	Ramp XSlope (%)	5.4
N/A	Flare Type LT	N/A	N/A	Flare Type RT	N/A
N/A	Flare Slope LT (%)	N/A	N/A	Flare Slope RT (%)	N/A
N/A	Flare Traversable LT?	N/A	N/A	Flare Traversable RT?	N/A
N/A	Landing Length (in)	N/A	N/A	DWS Provided?	N/A
N/A	Landing Width (in)	N/A	N/A	DWS Contrast?	N/A
N/A	Landing Slope (%)	N/A	N/A	DWS Length (in)	N/A
N/A	Landing X Slope (%)	N/A	N/A	DWS Full Width?	N/A
N/A	Landing Curb? (Y/N)	N/A	N/A	DWS Offset (in)	N/A
N/A	Shared Landing?	N/A			
N/A	Gutter Ponding?	N/A	N/A	Gutter Slope (%)	N/A
N/A	Gutter Lip Ht (in)	N/A	N/A	Gutter X Slope (%)	N/A
N/A	Painted X Walk1?	No	N/A	Painted X Walk2?	N/A
	X Walk 1 Direction	To SE		X Walk 2 Direction	N/A
N/A	X Walk 1 Width (in)	N/A	N/A	X Walk 2 Width (in)	N/A
	X Walk 1 Slope (%)	2.6		X Walk 2 Slope (%)	N/A
	X Walk 1 X Slope (%)	1.0		X Walk 2 X Slope (%)	N/A

Possible Solutions:

Remove & Replace Entire Ramp.

Total Cost: \$ 1850.00
