# Access Compliance Report

## Public Rights-of-Way

### (Curb Ramps)

| Intersection ID: 10477 | Main Street: HAMILTON_ST | Cross Street: POLK_ST | Location: W |

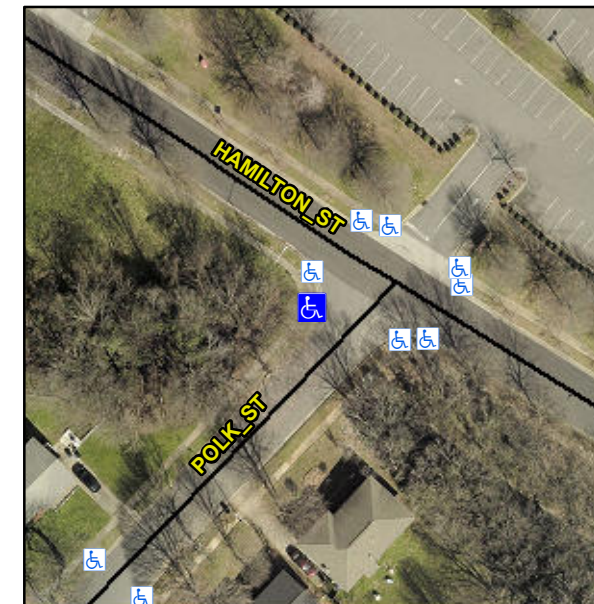
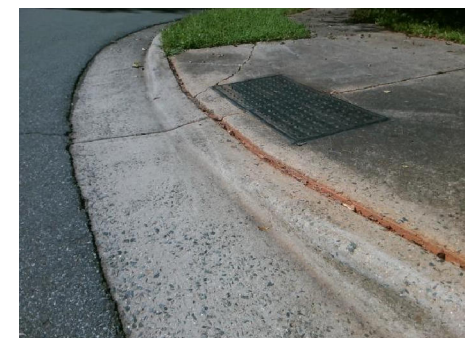
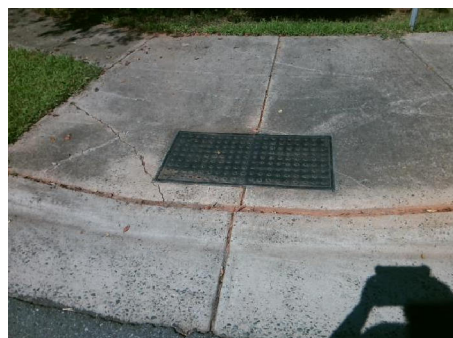
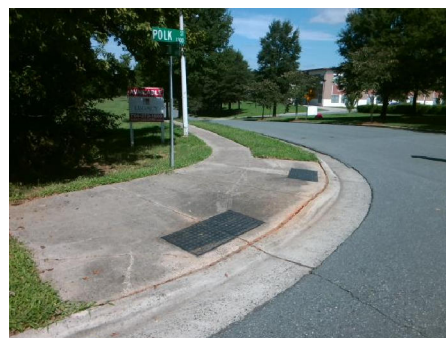
| ADA ID: F13DBC4A96B7 | Ramp Type: BlendTrans1 | Initial Pass/Fail: Fail | Overall Compliance: No |

**CURB LIP 1.5**

**Not Found, R304.5.1**

| Compliance | Description | Data | Compliance | Description | Data |
|---|---|---|---|---|---|
| No | Ramp Width (in) | 41.0 | Yes | BlendTrans XSlope (%) | 0.7 |
| | | | No | Curb Slope (%) | 21.0 |

**Remove & Replace Curb Ramp With Two New Directional Ramps or Equivalent.**
