Access Compliance Report Public Rights-of-Way (Curb Ramps)

Intersection ID: 12830 Main Street: CARYA_POND_LN Cross Street: HICKORY_GROVE_RD Location: N

ADA ID: F1C7A84A1355 Ramp Type: Combination1 Initial Pass/Fail: Fail Overall Compliance: No Severity Score: 22.5

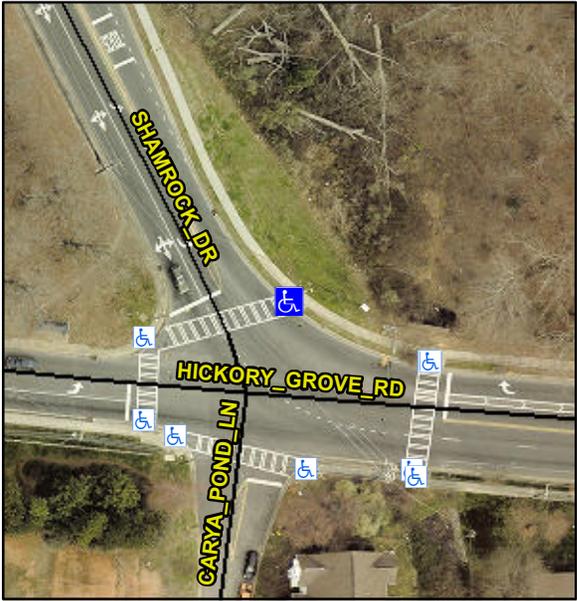
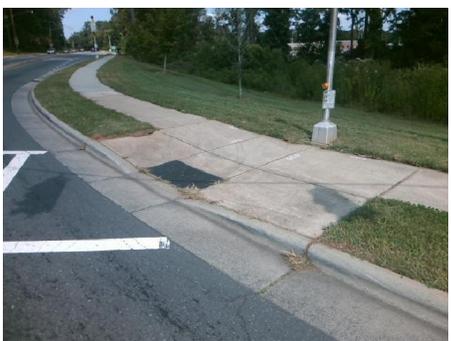
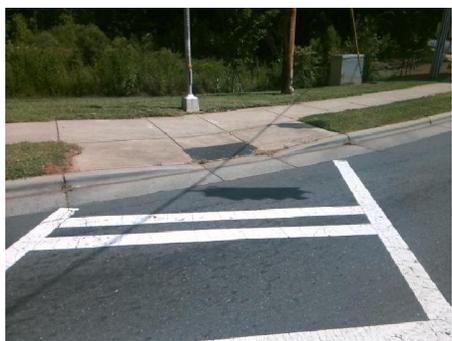
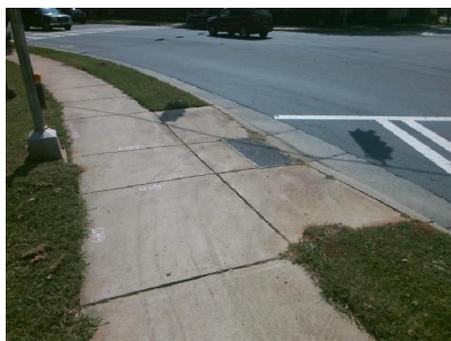
Surveyor Notes:
RT RP < 5%

PROW/ADA:
Not Found, R304.5.1, R304.2.2, R304.5.3

Compliance	Description	Data	Compliance	Description	Data
N/A	Ramp Length LT (in)	64.5	N/A	Ramp Length RT (in)	68.0
Yes	Ramp Width LT (in)	59.0	Yes	Ramp Width RT (in)	60.0
Yes	Ramp Slope LT (%)	7.3	Yes	Ramp Slope RT (%)	1.8
No	Ramp XSlope LT (%)	3.9	No	Ramp XSlope RT (%)	4.0
N/A	Ramp Length (in)	48.0	No	Ramp Slope (%)	9.1
No	Ramp Width (in)	45.5	No	Ramp XSlope (%)	3.4
N/A	Flare Type LT	N/A	N/A	Flare Type RT	N/A
N/A	Flare Slope LT (%)	N/A	N/A	Flare Slope RT (%)	N/A
N/A	Flare Traversable LT?	N/A	N/A	Flare Traversable RT?	N/A
N/A	Landing Length (in)	N/A	N/A	DWS Provided?	N/A
N/A	Landing Width (in)	N/A	N/A	DWS Contrast?	N/A
N/A	Landing Slope (%)	N/A	N/A	DWS Length (in)	N/A
N/A	Landing X Slope (%)	N/A	N/A	DWS Full Width?	N/A
N/A	Landing Curb? (Y/N)	N/A	N/A	DWS Offset (in)	N/A
N/A	Shared Landing?	N/A			
N/A	Gutter Ponding?	N/A	N/A	Gutter Slope (%)	N/A
N/A	Gutter Lip Ht (in)	N/A	N/A	Gutter X Slope (%)	N/A
N/A	Painted X Walk1?	Yes	N/A	Painted X Walk2?	N/A

Possible Solutions:
Remove & Replace Entire Ramp.
