Access Compliance Report Public Rights-of-Way (Curb Ramps)

Intersection ID: 9796Main Street:BARRINGTON_DRCross Street:MONTEGO_DRLocation:NWADA ID: F30BBFFC570DRamp Type:PerpInitial Pass/Fail:FailOverall Compliance:NoSeverity Score:22.5

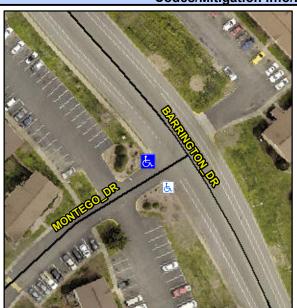
Field Measurements/Component Compliance							
Compl	liance Description	Data	Comp	liance Description	Data		
N/A	Ramp Length (in)	28.0	No	Ramp Slope (%)	10.5		
No	Ramp Width (in)	47.5	Yes	Ramp XSlope (%)	3.3		
N/A	Flare Type LT	N/A	N/A	Flare Type RT	N/A		
N/A	Flare Slope LT (%)	N/A	N/A	Flare Slope RT (%)	N/A		
N/A	Flare Traversable LT?	N/A	N/A	Flare Traversable RT?	N/A		
N/A	Landing Length (in)	N/A	N/A	DWS Provided?	N/A		
N/A	Landing Width (in)	N/A	N/A	DWS Contrast?	N/A		
N/A	Landing Slope (%)	N/A	N/A	DWS Length (in)	N/A		
N/A	Landing X Slope (%)	N/A	N/A	DWS Full Width?	N/A		
N/A	Landing Curb? (Y/N)	N/A	N/A	DWS Offset (in)	N/A		
N/A	Shared Landing?	N/A					
N/A	Gutter Ponding?	N/A	N/A	Gutter Slope (%)	N/A		
N/A	Gutter Lip Ht (in)	0.5	N/A	Gutter X Slope (%)	N/A		
N/A	Painted X Walk1?	No	N/A	Painted X Walk2?	N/A		
	X Walk 1 Direction	To SE		X Walk 2 Direction	N/A		
N/A	X Walk 1 Width (in)	N/A	N/A	X Walk 2 Width (in)	N/A

X Walk 1 Slope (%)	3.5		X Walk 2 Slope (%)	N/A		
	X Walk 1 X Slope (%)	4.6		X Walk 2 X Slope (%)	N/A		
N/A	Ramp inside XWalk1?	N/A	N/A	Ramp inside XWalk2?	N/A		
	Road Slope (%)	N/A	N/A	Clear Space?	N/A		
	Road X Slope (%)	N/A	N/A	Clear Space to XWalk (in)	N/A		
N/A	Any Obstructions?	N/A	N/A	Storm Grate/Utility Hazard?	N/A		
	Obstruction Type			Storm Grate/Utility Type			
		N/A			N/A		
			Yes	Surface Condition? (G/P)	Good		
The state of the s

1 OSSIDIE SOIGLIOII	
Possible Solutions:	<u>c</u>
Remove & Replace Entire Ramp.	N
•	N
	N
	N
	N
	N
Surveyor Notes:	N
N/A	N
	N
	N
	N
PROW/ADA:	N
Not Found, R304.5.1, R304.2.2	N
,	N
	N
