Access Compliance Report

Public Rights-of-Way

(Curb Ramps)

Intersection ID: 4923	Main Street: HEDGECREST_PL	Cross Street: MAYSPRING_PL	Location:	S
ADA ID: F35272BE3AA6	Ramp Type: Perp	Initial Pass/Fail: Fail	Overall Compliance: No	Severity Score: 25

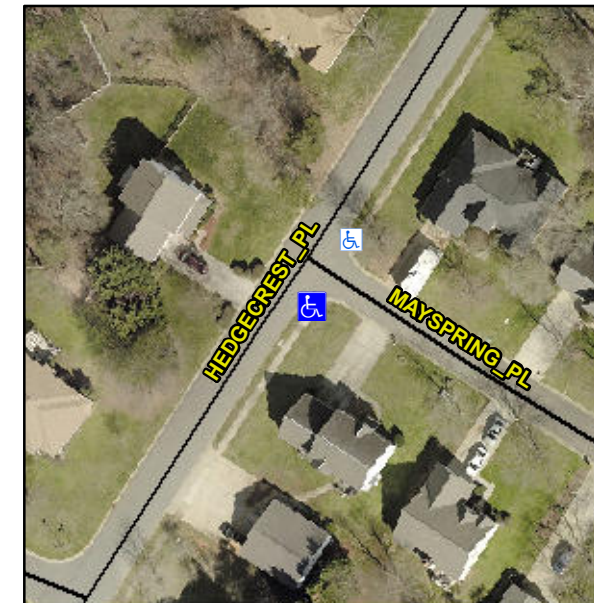
Not Found, R304.5.3

Compliance	Description	Data	Compliance	Description	Data
N/A	Ramp Length (in)	48.0	Yes	Ramp Slope (%)	7.2
Yes	Ramp Width (in)	48.0	No	Ramp XSlope (%)	10.0
N/A	Flare Type LT	N/A	N/A	Flare Type RT	N/A
N/A	Flare Slope LT (%)	N/A	N/A	Flare Slope RT (%)	N/A
N/A	Flare Traversable LT?	N/A	N/A	Flare Traversable RT?	N/A
N/A	Landing Length (in)	N/A	N/A	DWS Provided?	N/A
N/A	Landing Width (in)	N/A	N/A	DWS Contrast?	N/A
N/A	Landing Slope (%)	N/A	N/A	DWS Length (in)	N/A
N/A	Landing X Slope (%)	N/A	N/A	DWS Full Width?	N/A
N/A	Landing Curb? (Y/N)	N/A	N/A	DWS Offset (in)	N/A
N/A	Shared Landing?	N/A			
N/A	Gutter Ponding?	N/A	N/A	Gutter Slope (%)	N/A
N/A	Gutter Lip Ht (in)	N/A	N/A	Gutter X Slope (%)	N/A
N/A	Painted X Walk1?	No	N/A	Painted X Walk2?	N/A
	X Walk 1 Direction	To NE		X Walk 2 Direction	N/A
N/A	X Walk 1 Width (in)	N/A	N/A	X Walk 2 Width (in)	N/A
	X Walk 1 Slope (%)	0.8		X Walk 2 Slope (%)	N/A
	X Walk 1 X Slope (%)	8.4		X Walk 2 X Slope (%)	N/A

Remove & Replace Entire Ramp.
