## **Access Compliance Report Public Rights-of-Way** (Curb Ramps)

Intersection ID: 12248 Main Street: E\_8TH\_ST Cross Street: N\_BREVARD\_ST Location:

**Overall Compliance: No** ADA ID: F381DF9DF6EE Ramp Type: Perp Initial Pass/Fail: Fail Severity Score: 21.25

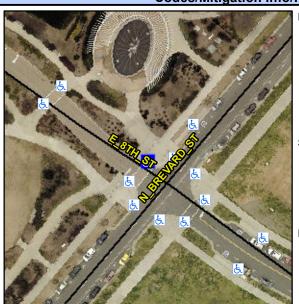
Fleid Measurements/Component Compilance							
Compliance Description		Data	Data Compliance Description		Data			
N/A	Ramp Length (in)	71.0	No	Ramp Slope (%)	8.7			
No	Ramp Width (in)	40.0	Yes	Ramp XSlope (%)	0.1			
N/A	Flare Type LT	N/A	N/A	Flare Type RT	N/A			
N/A	Flare Slope LT (%)	N/A	N/A	Flare Slope RT (%)	N/A			
N/A	Flare Traversable LT?	N/A	N/A	Flare Traversable RT?	N/A			
N/A	Landing Length (in)	N/A	N/A	DWS Provided?	N/A			
N/A	Landing Width (in)	N/A	N/A	DWS Contrast?	N/A			
N/A	Landing Slope (%)	N/A	N/A	DWS Length (in)	N/A			
N/A	Landing X Slope (%)	N/A	N/A	DWS Full Width?	N/A			
N/A	Landing Curb? (Y/N)	N/A	N/A	DWS Offset (in)	N/A			
N/A	Shared Landing?	N/A						
N/A	Gutter Ponding?	N/A	N/A	Gutter Slope (%)	N/A			
N/A	Gutter Lip Ht (in)	N/A	N/A	Gutter X Slope (%)	N/A			
N/A	Painted X Walk1?	Yes	N/A	Painted X Walk2?	N/A			
	X Walk 1 Direction	To SW		X Walk 2 Direction	N/A			
N/A	X Walk 1 Width (in)	123.0	N/A	X Walk 2 Width (in)	N/A

X Walk 1 Slope (%)	2.1		X Walk 2 Slope (%)	N/A			
	X Walk 1 X Slope (%)	0.2		X Walk 2 X Slope (%)	N/A			
N/A	Ramp inside XWalk1?	Yes	N/A	Ramp inside XWalk2?	N/A			
	Road Slope (%)	N/A	N/A	Clear Space?	N/A			
	Road X Slope (%)	N/A	N/A	Clear Space to XWalk (in)	N/A			
N/A	Any Obstructions?	N/A	N/A	Storm Grate/Utility Hazard?	N/A			
	Obstruction Type			Storm Grate/Utility Type				
		N/A			N/A			
			Yes	Surface Condition? (G/P)	Good			
44	dieta A

Possible Solution	
Possible Solutions:	Con
Remove & Replace Entire Ramp.	N/A
	No
	N/A
	N/A
	N/A
	N/A
Surveyor Notes:	N/A
SLOPES VERIFIED & MATCH	N/A
	N/A
	N/A
	N/A
PROW/ADA:	N/A
R304.5.1, R304.2.2	N/A
·	N/A
	N/A
	N/A
