## Access Compliance Report Public Rights-of-Way (Curb Ramps)

Intersection ID: 54709 Main Street: MARY\_BUTLER\_WY Cross Street: OLD\_PROVIDENCE\_RD Location: SE

ADA ID: F3D7D63657DD Ramp Type: Perp Initial Pass/Fail: Fail Overall Compliance: No Severity Score: 12.5

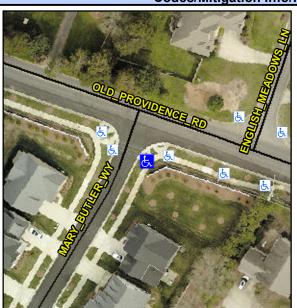
Compliance Description		Data	Compliance Description		Data
N/A	Ramp Length (in)	95.0	Yes	Ramp Slope (%)	7.4
Yes	Ramp Width (in)	71.0	No	Ramp XSlope (%)	5.7
N/A	Flare Type LT	N/A	N/A	Flare Type RT	N/A
N/A	Flare Slope LT (%)	N/A	N/A	Flare Slope RT (%)	N/A
N/A	Flare Traversable LT?	N/A	N/A	Flare Traversable RT?	N/A
N/A	Landing Length (in)	N/A	N/A	DWS Provided?	N/A
N/A	Landing Width (in)	N/A	N/A	DWS Contrast?	N/A
N/A	Landing Slope (%)	N/A	N/A	DWS Length (in)	N/A
N/A	Landing X Slope (%)	N/A	N/A	DWS Full Width?	N/A
N/A	Landing Curb? (Y/N)	N/A	N/A	DWS Offset (in)	N/A
N/A	Shared Landing?	N/A			
N/A	Gutter Ponding?	N/A	N/A	Gutter Slope (%)	N/A
N/A	Gutter Lip Ht (in)	N/A	N/A	Gutter X Slope (%)	N/A
N/A	Painted X Walk1?	No	N/A	Painted X Walk2?	N/A
	X Walk 1 Direction	To W		X Walk 2 Direction	N/A
N/A	X Walk 1 Width (in)	N/A	N/A	X Walk 2 Width (in)	N/A
	X Walk 1 Slope (%)	2.0		X Walk 2 Slope (%)	N/A
	X Walk 1 X Slope (%)	5.8		X Walk 2 X Slope (%)	N/A

Remove & Replace Entire Ramp.

PROW/ADA:
R304.5.3
