Access Compliance Report

Public Rights-of-Way

| Intersection ID: 48568 | Main Street: BRAMBLE RIDGE CT | Cross Street: SALAMANDER RUN LN | Location: NW |
| ADA ID: F3D7E2DA67A1 | Ramp Type: PerpDiag | Initial Pass/Fail: Fail | Overall Compliance: No |

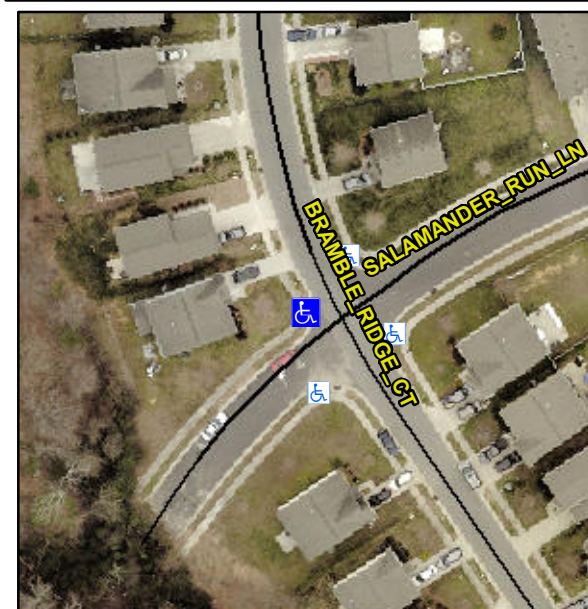
| | | Severity Score: 12.5 | |

Not Found, R304.2.2

| Compliance | Description | Data | Compliance | Description | Data |
|---|---|---|---|---|---|
| N/A | Ramp Length (in) | 46.0 | No | Ramp Slope (%) | 9.1 |

Remove & Replace Curb Ramp With Two New Directional Ramps or Equivalent.
