# Access Compliance Report

## Public Rights-of-Way

| Intersection ID: 10010 | Main Street: DUNCROFT_LN | Cross Street: E_W_T_HARRIS_BV | Location: NW |
| ADA ID: F3E09DED75C6 | Ramp Type: PerpDiag | Initial Pass/Fail: Fail | Overall Compliance: No |

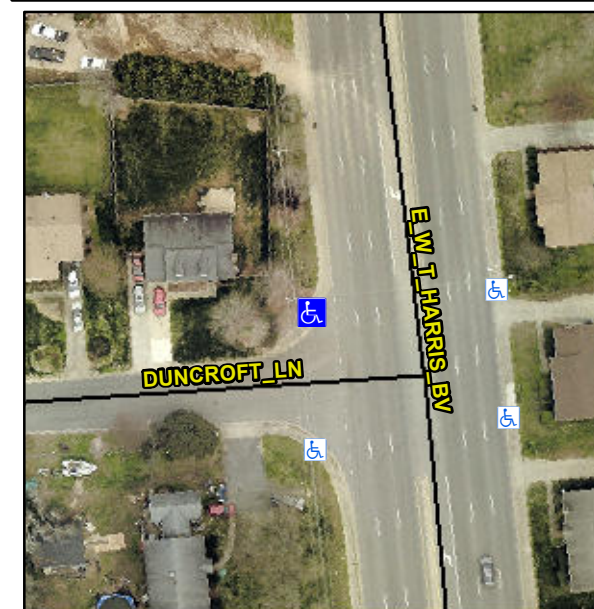
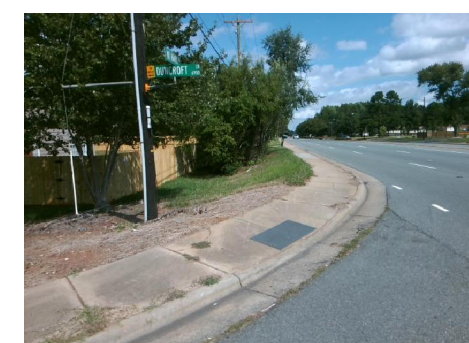
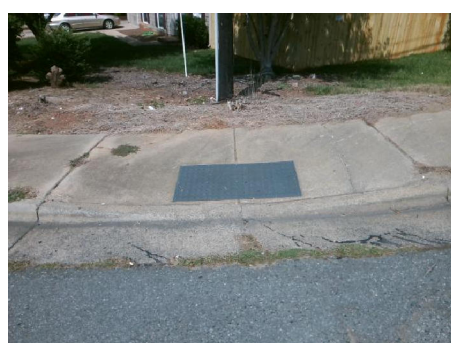
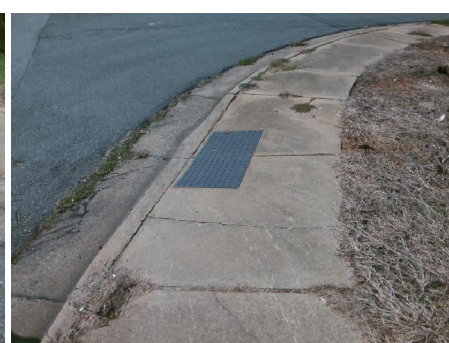
| Severity Score: 58.75 | | | |

**Not Found, R304.5.1, R304.2.2, R304.5.3**

| Compliance | Description | Data | Compliance | Description | Data |
|---|---|---|---|---|---|
| N/A | Ramp Length (in) | 60.5 | No | Ramp Slope (%) | 12.8 |
| No | Ramp Width (in) | 39.0 | No | Ramp XSlope (%) | 8.0 |

**Remove & Replace Curb Ramp With Two New Directional Ramps or Equivalent.**

Total Cost: \$ 3200.00
