# Access Compliance Report

## Public Rights-of-Way

### (Curb Ramps)

Intersection ID: 10032191		Main Street: MORRISON_BV		Cross Street: N/A		Location:		NW											
ADA ID: F3F6E54CB939		Ramp Type: Directional1		Initial Pass/Fail: Fail		Overall Compliance: No		Severity Score: 25											
Codes/Mitigation Info/Possible Solution				Field Measurements/Component Compliance

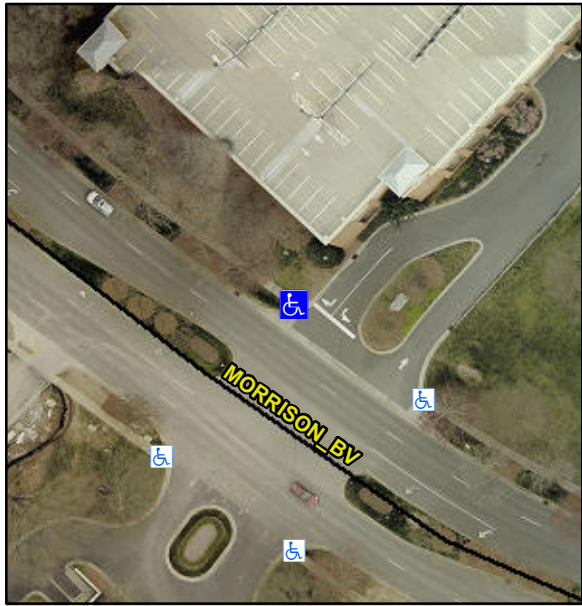
<div>Street 1 NameENTRANCE</div> <div>Stop Condition-Street 1StopSign</div> <div>Street 2 NameN/A</div> <div>Stop Condition-Street 2N/A</div>				Possible Solutions:		Compliance		Description		Data		Compliance		Description		Data			
				Remove & Replace Entire Ramp.		N/A		Ramp Length (in)		60.0		N/A		Grade Break?		N/A		N/A	
						Yes		Ramp Width (in)		60.0		N/A		Grade Break Slope (%)		0.0		0.0	
						Yes		Ramp Slope (%)		7.6		N/A		Grade Break XSlope (%)		0.0			
						No		Ramp XSlope (%)		7.8									
						N/A		Flare Type LT		N/A		N/A		Flare Type RT		N/A			
						N/A		Flare Slope LT (%)		N/A		N/A		Flare Slope RT (%)		0.0

N/A		Flare Traversable LT?		N/A		N/A		Flare Traversable RT?		N/A			
						N/A		Landing Length (in)		0.0		N/A		DWS Provided?		N/A			
						N/A		Landing Width (in)		0.0		N/A		DWS Contrast?		N/A			
		N/A		Landing Slope (%)		0.0		N/A		DWS Length (in)		N/A							
		N/A		Landing X Slope (%)		0.0		N/A		DWS Full Width?		N/A							
		N/A		Landing Curb? (Y/N)		N/A		N/A		DWS Offset LT (in)		N/A							
		N/A		Shared Landing?		N/A		N/A		DWS Offset RT (in)		N/A							
		N/A		Gutter Ponding?		0.0		N/A		Gutter Slope (%)		N/A							
		N/A		Gutter Lip Ht (in)		0.0		N/A		Gutter X Slope (%)		N/A							
		N/A		Painted X Walk1?		No				Road Slope (%)		2.7							
				X Walk 1 Direction		To SE				Road X Slope (%)		4.3							
				X Walk 1 Width (in)		N/A				Clear Space?		N/A							
				X Walk 1 Slope (%)		2.7		N/A		Clear Space to XWalk (in)		N/A							
				X Walk 1 X Slope (%)		4.3		N/A		Storm Grate/Utility Hazard?		N/A

N/A		Ramp inside XWalk1?		N/A				Storm Grate/Utility Type									
		N/A		Any Obstructions?		N/A						N/A							
				Obstruction Type				Yes		Surface Condition? (G/P)		Good							
								N/A		N/A		Curb Slope (%)		16.3					
Surveyor Notes:				N/A															
PROW/ADA:				R304.5.3
