Access Compliance Report Public Rights-of-Way (Curb Ramps)

Intersection ID: 26384 Main Street: BEVINGTON_PL **Cross Street: ELM LN** Location: NE **Overall Compliance: No ADA ID: F56A0FDBE1EE** Ramp Type: Perp Initial Pass/Fail: Fail Severity Score: 13.75

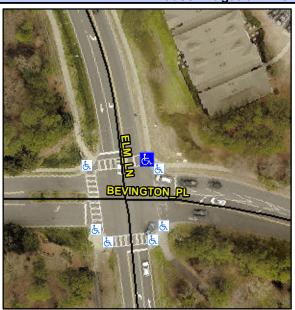
| Possible Solutions: | Comp | liance | Description |
|---|---|---|---|
| Not Found, R304.2.2, R304.5.3 | N/A | Gutte | er Lip Ht (in) |

| Possible Solutions: | Comp | liance | Description |
|---|---|---|---|
| Remove & Replace Entire Ramp. | N/A | Ram | p Length (in) |
