Access Compliance Report

Public Rights-of-Way

| Intersection ID: 8754 | Main Street: BEATTIES_FORD_RD | Cross Street: ST_PAUL_ST | Location: NE |
| ADA ID: F586C39F2292 | Ramp Type: Perp | Initial Pass/Fail: Fail | Overall Compliance: No |

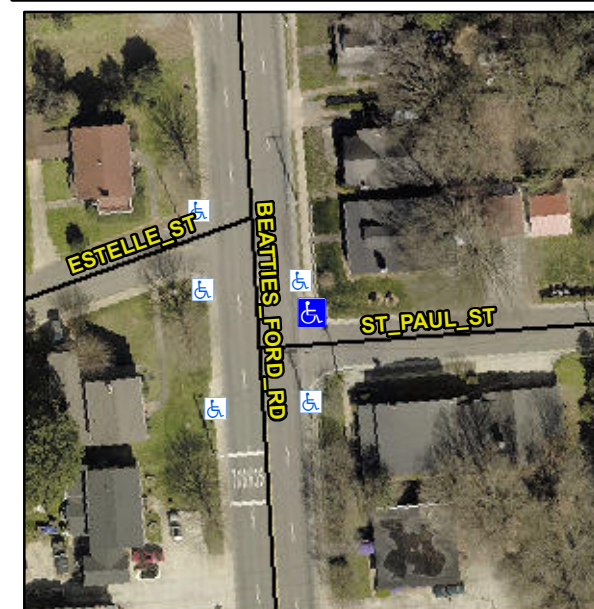
| Severity Score: 22.5 | | | |

Not Found, R304.5.1, R304.2.2, R304.5.3

| Compliance | Description | Data | Compliance | Description | Data |
|---|---|---|---|---|---|
| N/A | Ramp Length (in) | 57.0 | No | Ramp Slope (%) | 8.7 |
| No | Ramp Width (in) | 45.5 | No | Ramp XSlope (%) | 4.5 |

Remove & Replace Entire Ramp.
