Access Compliance Report

Public Rights-of-Way

(Curb Ramps)

Intersection ID: 14278	Main Street: ROMARE_BEARDEN_DR	Cross Street: FARMER_ST	Location:	N
ADA ID: F5B135B2FE66	Ramp Type: MedianPerp	Initial Pass/Fail: Fail	Overall Compliance: No	Severity Score: 13.75
Codes/Mitigation Info/Possible Solution		Field Measurements/Component Compliance

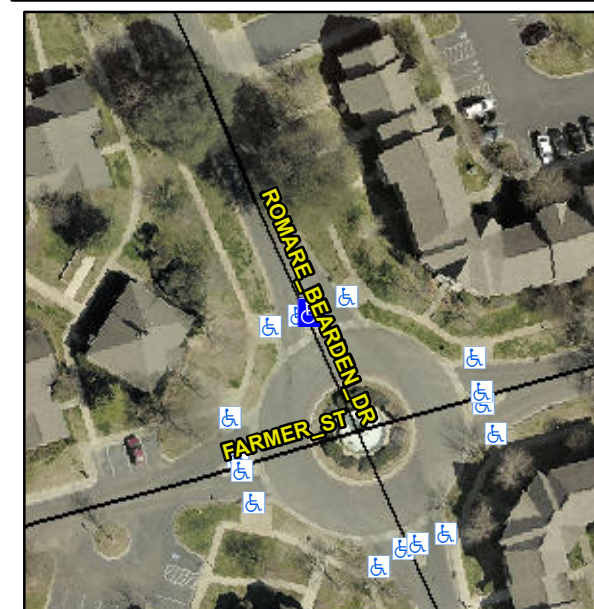
Not Found, R304.2.2, R304.5.3

Compliance	Description	Data	Compliance	Description	Data
N/A	Ramp Length (in)	40.0	No	Ramp Slope (%)	9.0
Yes	Ramp Width (in)	48.0	No	Ramp XSlope (%)	3.3
N/A	Flare Type LT	N/A	N/A	Flare Type RT	N/A
N/A	Flare Slope LT (%)	N/A	N/A	Flare Slope RT (%)	N/A
N/A	Flare Traversable LT?	N/A	N/A	Flare Traversable RT?	N/A
N/A	Landing Length (in)	N/A	N/A	DWS Provided?	N/A
N/A	Landing Width (in)	N/A	N/A	DWS Contrast?	N/A
N/A	Landing Slope (%)	N/A	N/A	DWS Length (in)	N/A
N/A	Landing X Slope (%)	N/A	N/A	DWS Full Width?	N/A
N/A	Landing Curb? (Y/N)	N/A	N/A	DWS Offset (in)	N/A
N/A	Shared Landing?	N/A			
N/A	Gutter Ponding?	N/A	N/A	Gutter Slope (%)	N/A
N/A	Gutter Lip Ht (in)	N/A	N/A	Gutter X Slope (%)	N/A
N/A	Painted X Walk1?	No	N/A	Painted X Walk2?	N/A
	X Walk 1 Direction	To E		X Walk 2 Direction	N/A
N/A	X Walk 1 Width (in)	N/A	N/A	X Walk 2 Width (in)	N/A
	X Walk 1 Slope (%)	0.7		X Walk 2 Slope (%)	N/A
	X Walk 1 X Slope (%)	2.0		X Walk 2 X Slope (%)	N/A

Remove & Replace Entire Ramp.
