# Access Compliance Report

## Public Rights-of-Way

### (Curb Ramps)

| Intersection ID: 44449 | Main Street: BAYVIEW_PY | Cross Street: PRESTBURY_BV | Location: W |

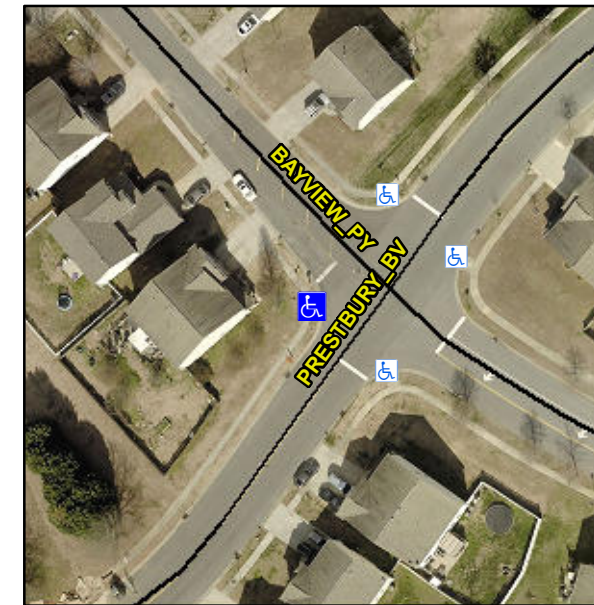
| ADA ID: F5F190E629B1 | Ramp Type: BlendTrans1 | Initial Pass/Fail: Fail | Overall Compliance: No |

**Not Found, R304.5.1, R304.5.3**

| Compliance | Description | Data | Compliance | Description | Data |
|---|---|---|---|---|---|
| No | Ramp Width (in) | 40.0 | No | BlendTrans XSlope (%) | 4.2 |

**Remove & Replace Curb Ramp With Two New Directional Ramps or Equivalent.**
