## **Access Compliance Report Public Rights-of-Way** (Curb Ramps)

Intersection ID: 48423 Main Street: EVANTON LOCH RD **Cross Street: BEDLINGTON RD** Location: SE **ADA ID: F6AAF308561A** Ramp Type: BlendTrans1 Initial Pass/Fail: Fail **Overall Compliance: No Severity Score:** 12.5

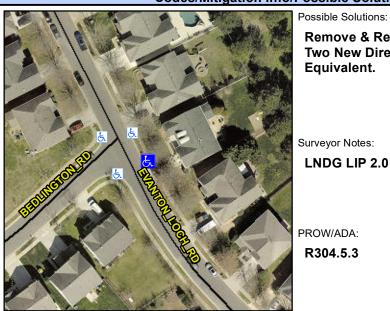
**LNDG LIP 2.0**

R304.5.3

Compliance Description		Data	Compliance Description		Data
N/A	Ramp Length (in)	47.0	Yes	BlendTrans Slope (%)	1.8
Yes	Ramp Width (in)	48.0	No	BlendTrans XSlope (%)	5.3
N/A	Flare Type LT	N/A	N/A	Flare Type RT	N/A
N/A	Flare Slope LT (%)	N/A	N/A	Flare Slope RT (%)	N/A
N/A	Flare Traversable LT?	N/A	N/A	Flare Traversable RT?	N/A
N/A	Landing Length (in)	N/A	N/A	DWS Provided?	N/A
N/A	Landing Width (in)	N/A	N/A	DWS Contrast?	N/A
N/A	Landing Slope (%)	N/A	N/A	DWS Length (in)	N/A
N/A	Landing X Slope (%)	N/A	N/A	DWS Full Width?	N/A
N/A	Landing Curb? (Y/N)	N/A	N/A	DWS Offset (in)	N/A
N/A	Shared Landing?	N/A			
N/A	Gutter Ponding?	N/A	N/A	Gutter Slope (%)	N/A
N/A	Gutter Lip Ht (in)	N/A	N/A	Gutter X Slope (%)	N/A
N/A	Painted X Walk1?	No	N/A	Painted X Walk2?	N/A
	X Walk 1 Direction	To SW		X Walk 2 Direction	N/A
	X Walk 1 Width (in)	N/A		X Walk 2 Width (in)	N/A
	X Walk 1 Slope (%)	3.3		X Walk 2 Slope (%)	N/A
	X Walk 1 X Slope (%)	4.8		X Walk 2 X Slope (%)	N/A

Remove & Replace Curb Ramp With Two New Directional Ramps or Equivalent.
