Access Compliance Report Public Rights-of-Way (Curb Ramps)

Intersection ID: 10029840Main Street: KRISLYN_WOODS_PLCross Street: N/ALocation:SWADA ID: F71249E4F363Ramp Type: PerpInitial Pass/Fail: FailOverall Compliance: NoSeverity Score: 21.25

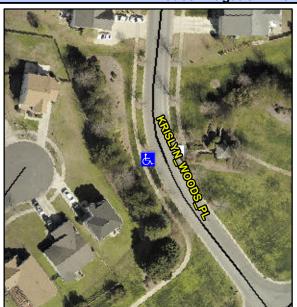
| 1 099IDIE OOIGHOH | | | | |
|---|--|--|--|--|
| Not Found, R304.5.1, R304.2.2 | | | | |

| Field Measurements/Component Compliance | | | | | | |
|---|---|---|---|---|---|--|
| N/A | Ramp Length (in) | 85.0 | No | Ramp Slope (%) | 8.8 | |
| No | Ramp Width (in) | 47.0 | Yes | Ramp XSlope (%) | 0.7 | |

| 1 099IDIE OOIGHOH | | | | |
|---|--|--|--|--|
| Remove & Replace Entire Ramp. | | | | |
