# Access Compliance Report

## Public Rights-of-Way

### (Curb Ramps)

| Intersection ID: 4883 | Main Street: HEDGECREST_PL | Cross Street: MARIONWOOD_DR | Location: NE |

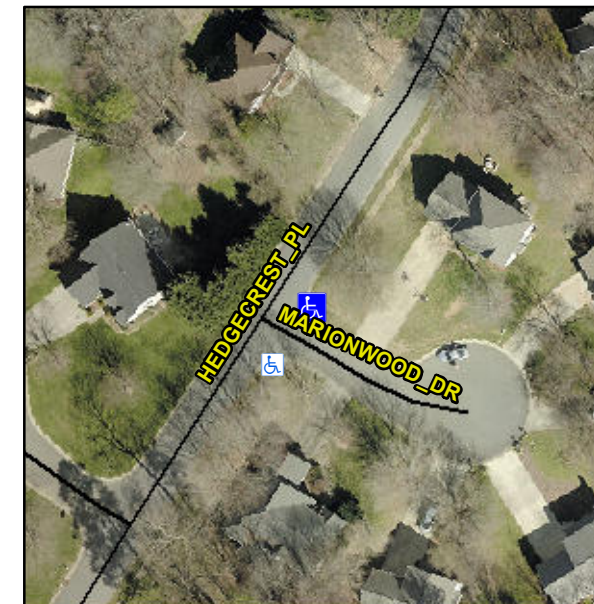
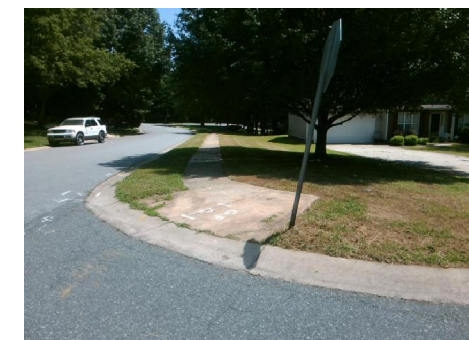
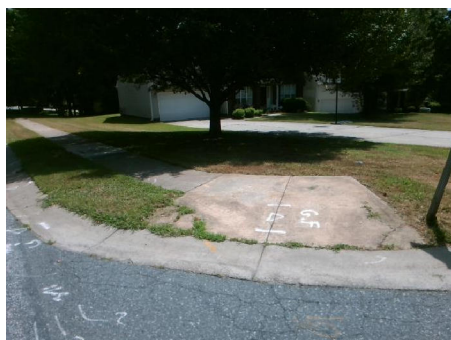
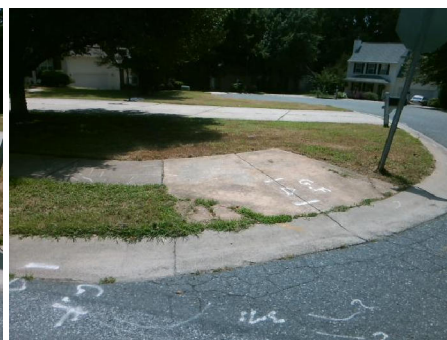
| ADA ID: F7724FBE98AE | Ramp Type: Perp | Initial Pass/Fail: Fail | Overall Compliance: No |

**Not Found, R304.2.2**

| Compliance | Description | Data | Compliance | Description | Data |
|---|---|---|---|---|---|
| N/A | Ramp Length (in) | 48.0 | No | Ramp Slope (%) | 12.3 |

**Remove & Replace Entire Ramp.**
