# Access Compliance Report

## Public Rights-of-Way

### (Curb Ramps)

| Intersection ID: 14471 | Main Street: DILWORTH_RD | Cross Street: LINGANORE_PL | Location: NE |

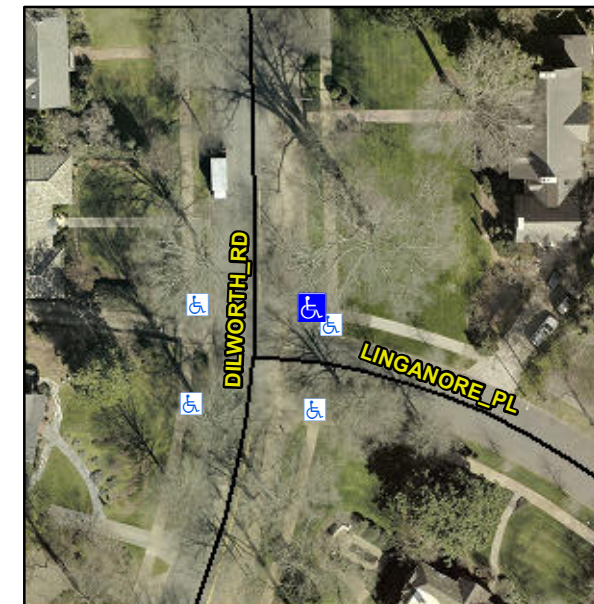
| Compliance | Description | Data | Compliance | Description | Data |
|---|---|---|---|---|---|
| Yes | Ramp Slope (%) | 5.1 | No | Grade Break XSlope (%) | 3.2 |
| No | Ramp XSlope (%) | 2.3 | | | |
| Yes | Landing Length (in) | 72.0 | No | DWS Provided? | No |
| No | Landing X Slope (%) | 2.5 | N/A | DWS Full Width? | No |
| Yes | Gutter Ponding? | No | No | Gutter Slope (%) | 5.5 |

**Remove & Replace Entire Ramp.  
Remove & Replace Gutter.**
