# Access Compliance Report

## Public Rights-of-Way

| Intersection ID: 5827 | Main Street: ST_JOSEPH_DR | Cross Street: OLSEN_LN | Location: S |
| ADA ID: F7F782B87F28 | Ramp Type: BlendTrans1 | Initial Pass/Fail: Pass | Overall Compliance: No |

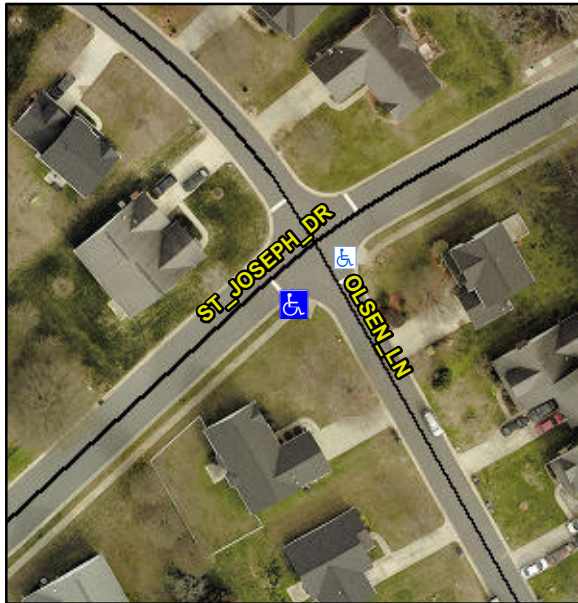
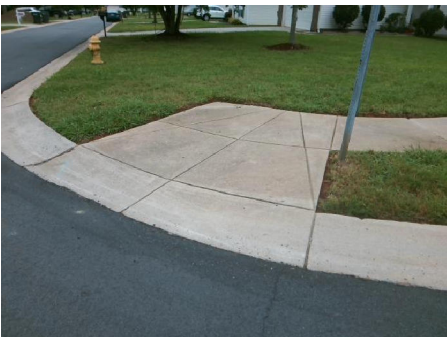
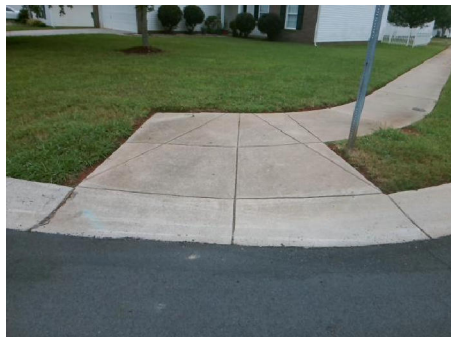
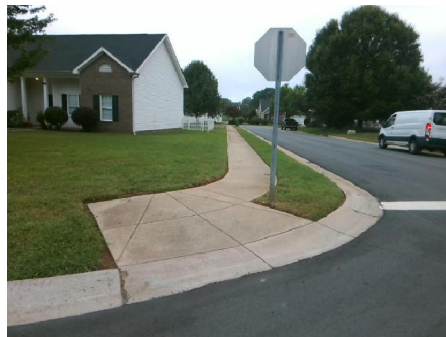
**NO LT SW**

**R304.2.2-Perp, R304.3.2-Para, R304.5.3, R305, R302.7.2**

| Compliance | Description | Data | Compliance | Description | Data |
|---|---|---|---|---|---|
| Yes | Landing Length (in) | 52.0 | No | DWS Provided? | No |
| No | Landing Slope (%) | 3.9 | N/A | DWS Length (in) | N/A |
| No | Landing X Slope (%) | 4.5 | N/A | DWS Full Width? | No |
| No | Gutter Lip Ht (in) | 0.3 | No | Gutter X Slope (%) | 3.4 |

**Remove & Replace Curb Ramp With Two New Directional Ramps or Equivalent. Remove & Replace Gutter.**
