Access Compliance Report

Public Rights-of-Way

| Intersection ID: 10022718 | Main Street: CAROWINDS_BV | Cross Street: N/A | Location: NW |
| ADA ID: F836C5147C94 | Ramp Type: PerpDiag | Initial Pass/Fail: Fail | Overall Compliance: No |

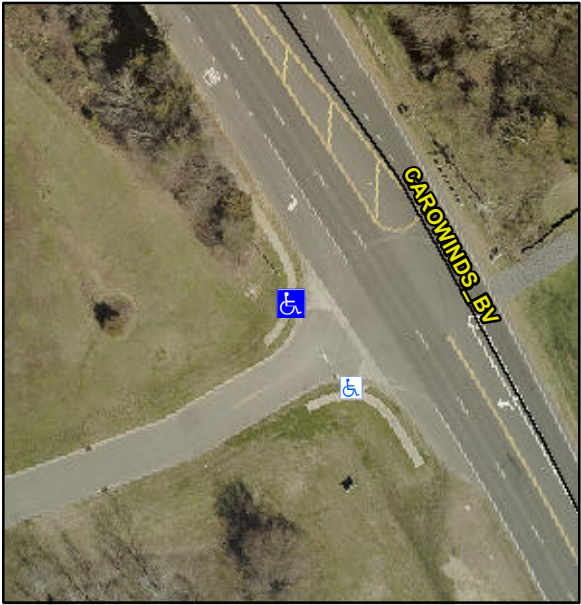
| Codes/Mitigation Info/Possible Solution | | | Field Measurements/Component Compliance | | |
|--|---|---|---|---|---|
| | Remove & Replace Curb Ramp With Two New Directional Ramps or Equivalent. | | No | Ramp Length (in) | 50.0 |
| | | | No | Ramp Width (in) | 37.5 |
| <p>Surveyor Notes:</p> <p>N/A</p> <p>PROW/ADA:</p> <p>R304.5.1, R304.2.2</p> | | | N/A | Flare Type RT | N/A |

| Codes/Mitigation Info/Possible Solution | | | Field Measurements/Component Compliance | | |
|--|---|---|---|---|---|
| | Possible Solutions: | | Compliance | Description | Data |
