Access Compliance Report Public Rights-of-Way (Curb Ramps)

Intersection ID: 28350 Main Street: REA_RD Cross Street: LINDAHI_LN Location: SW

ADA ID: F8DAF5B3A519 Ramp Type: PerpDiag Initial Pass/Fail: Fail Overall Compliance: No Severity Score: 12.5

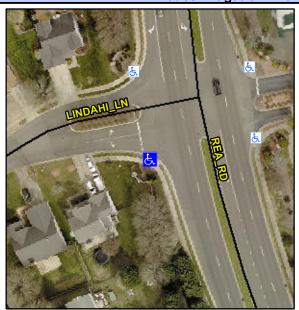
Not Found, R304.2.2

Field Measurements/Component Compliance							
	Compliance Description		Data	Compliance Description		Description	Data
	N/A	Ramp Length (in)	41.0	No	Ramp	Slope (%)	8.9
	Yes	Ramp Width (in)	62.0	Yes	Ramp	XSlope (%)	0.5
	N/A	Flare Type LT	N/A	N/A	Flare	Type RT	N/A
	N/A	Flare Slope LT (%)	N/A	N/A	Flare	Slope RT (%)	N/A
	N/A	Flare Traversable LT?	N/A	N/A	Flare	Traversable RT?	N/A
	N/A	Landing Length (in)	N/A	N/A	DWS	Provided?	N/A
	N/A	Landing Width (in)	N/A	N/A	DWS	Contrast?	N/A
	N/A	Landing Slope (%)	N/A	N/A	DWS	Length (in)	N/A
	N/A	Landing X Slope (%)	N/A	N/A	DWS	Full Width?	N/A
	N/A	Landing Curb? (Y/N)	N/A	N/A	DWS	Offset (in)	N/A
	N/A	Shared Landing?	N/A				
	N/A	Gutter Ponding?	N/A	N/A	Gutte	r Slope (%)	N/A
	N/A	Gutter Lip Ht (in)	N/A	N/A	Gutte	r X Slope (%)	N/A
	N/A	Painted X Walk1?	No	N/A	Painte	ed X Walk2?	No
		X Walk 1 Direction	То Е		X Wal	k 2 Direction	To N
	N/A	X Walk 1 Width (in)	N/A	N/A	X Wal	k 2 Width (in)	N/A

X Walk 1 Slope (%)	4.0		X Wal	k 2 Slope (%)	1.0
		X Walk 1 X Slope (%)	0.9		X Wal	k 2 X Slope (%)	3.1
	N/A	Ramp inside XWalk1?	N/A	N/A	Ramp	inside XWalk2?	N/A
		Road Slope (%)	1.9	N/A	Clear	Space?	N/A
		Road X Slope (%)	4.2	N/A	Clear	Space to XWalk (in)	N/A
	N/A	Any Obstructions?	N/A	N/A	Storm	Grate/Utility Hazard?	N/A
		Obstruction Type			Storm	Grate/Utility Type	
			N/A				N/A
				Yes	Surfac	ce Condition? (G/P)	Good

Remove & Replace Curb Ramp With
Two New Directional Ramps or
Equivalent.
