Access Compliance Report

Public Rights-of-Way

(Curb Ramps)

| Intersection ID: 50602 | Main Street: RHODORA_RD | Cross Street: CEDARFIELD_RD | Location: NE |

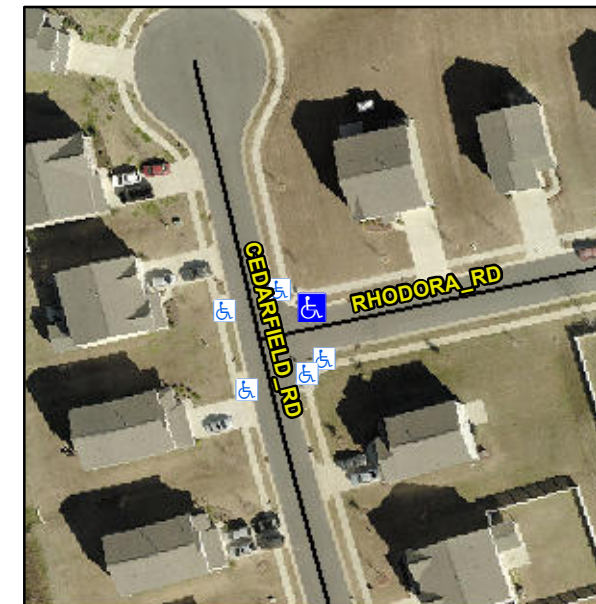
| ADA ID: F94B9F2D43B4 | Ramp Type: Perp | Initial Pass/Fail: Fail | Overall Compliance: No |
| Severity Score: 35 | | | |

Not Found, R304.5.1, R304.2.2, R304.5.3

| Compliance | Description | Data | Compliance | Description | Data |
|---|---|---|---|---|---|
| N/A | Ramp Length (in) | 50.0 | No | Ramp Slope (%) | 12.1 |
| No | Ramp Width (in) | 47.0 | No | Ramp XSlope (%) | 3.2 |

Remove & Replace Entire Ramp.
