# Access Compliance Report

## Public Rights-of-Way

### (Curb Ramps)

Intersection ID: 10748	Main Street: JOHNSON_ST	Cross Street: POLK_ST	Location:	S
ADA ID: F9AA2066C36C	Ramp Type: Combination1	Initial Pass/Fail: Fail	Overall Compliance: No	Severity Score: 22.5
Codes/Mitigation Info/Possible Solution		Field Measurements/Component Compliance

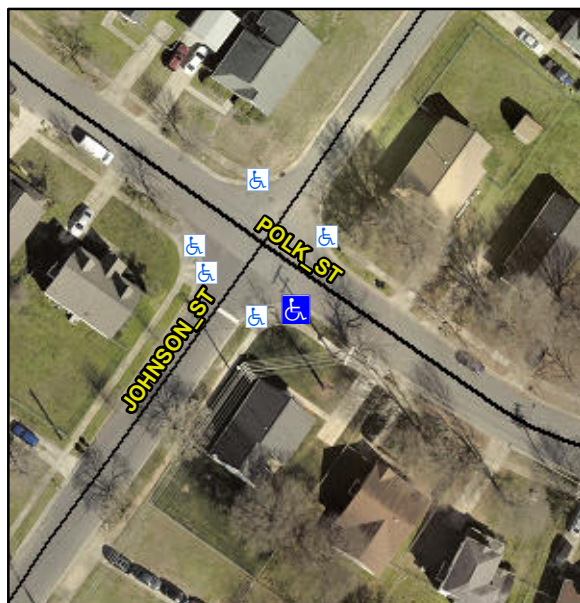
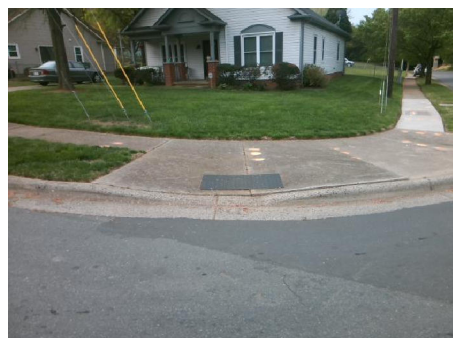
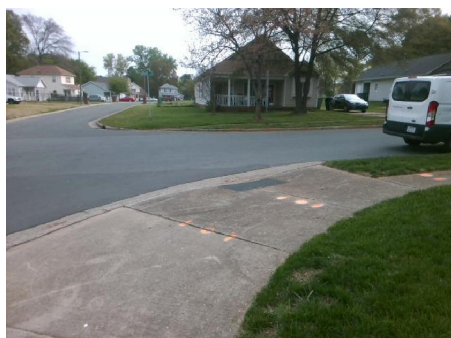
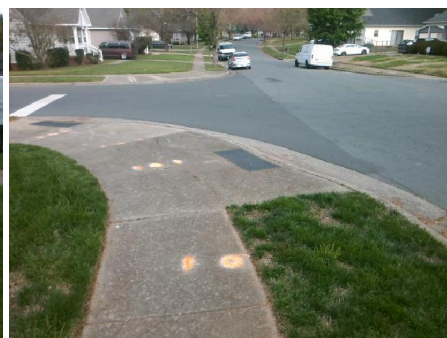
**CURB LIP, CURB GAP 1.5"**

**Not Found, R304.5.1, R304.2.2, R304.5.3**

Compliance	Description	Data	Compliance	Description	Data
N/A	Ramp Length LT (in)	33.0	N/A	Ramp Length RT (in)	56.0
Yes	Ramp Width LT (in)	48.0	Yes	Ramp Width RT (in)	50.0
Yes	Ramp Slope LT (%)	6.1	Yes	Ramp Slope RT (%)	6.0
No	Ramp XSlope LT (%)	4.5	No	Ramp XSlope RT (%)	3.4
N/A	Ramp Length (in)	64.0	No	Ramp Slope (%)	8.6
No	Ramp Width (in)	40.0	Yes	Ramp XSlope (%)	2.5
N/A	Flare Type LT	N/A	N/A	Flare Type RT	N/A
N/A	Flare Slope LT (%)	N/A	N/A	Flare Slope RT (%)	N/A
N/A	Flare Traversable LT?	N/A	N/A	Flare Traversable RT?	N/A
N/A	Landing Length (in)	N/A	N/A	DWS Provided?	N/A
N/A	Landing Width (in)	N/A	N/A	DWS Contrast?	N/A
N/A	Landing Slope (%)	N/A	N/A	DWS Length (in)	N/A
N/A	Landing X Slope (%)	N/A	N/A	DWS Full Width?	N/A
N/A	Landing Curb? (Y/N)	N/A	N/A	DWS Offset (in)	N/A
N/A	Shared Landing?	N/A			
N/A	Gutter Ponding?	N/A	N/A	Gutter Slope (%)	N/A
N/A	Gutter Lip Ht (in)	N/A	N/A	Gutter X Slope (%)	N/A
N/A	Painted X Walk1?	No	N/A	Painted X Walk2?	N/A

**Remove & Replace Entire Ramp.**
