# Access Compliance Report

## Public Rights-of-Way

### (Curb Ramps)

Intersection ID: 49817	Main Street: ASHLEY_VIEW_DR	Cross Street: SIDNEY_CREST_AV	Location: E
ADA ID: F9B34FB572F1	Ramp Type: PerpDiag	Initial Pass/Fail: Fail	Overall Compliance: No
Severity Score: 33.75			
Codes/Mitigation Info/Possible Solution		Field Measurements/Component Compliance

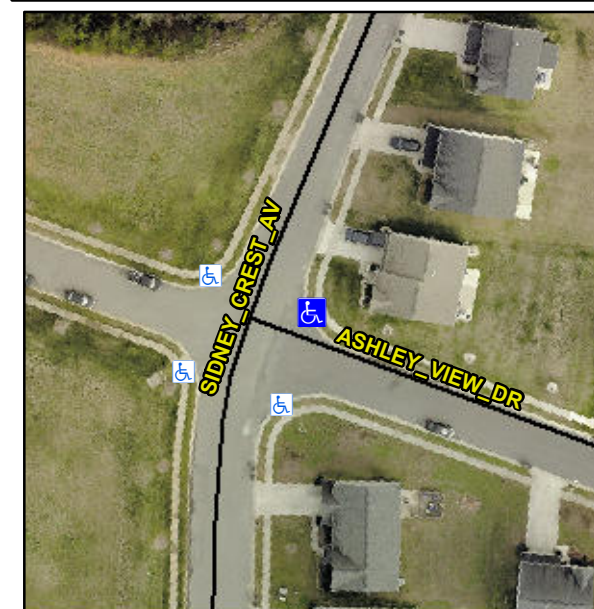
**Not Found, R304.5.1, R304.2.2, R304.5.3**

Compliance	Description	Data	Compliance	Description	Data
N/A	Ramp Length (in)	48.0	No	Ramp Slope (%)	11.4
No	Ramp Width (in)	40.0	No	Ramp XSlope (%)	6.7
N/A	Flare Type LT	N/A	N/A	Flare Type RT	N/A
N/A	Flare Slope LT (%)	N/A	N/A	Flare Slope RT (%)	N/A
N/A	Flare Traversable LT?	N/A	N/A	Flare Traversable RT?	N/A
N/A	Landing Length (in)	N/A	N/A	DWS Provided?	N/A
N/A	Landing Width (in)	N/A	N/A	DWS Contrast?	N/A
N/A	Landing Slope (%)	N/A	N/A	DWS Length (in)	N/A
N/A	Landing X Slope (%)	N/A	N/A	DWS Full Width?	N/A
N/A	Landing Curb? (Y/N)	N/A	N/A	DWS Offset (in)	N/A
N/A	Shared Landing?	N/A			
N/A	Gutter Ponding?	N/A	N/A	Gutter Slope (%)	N/A
N/A	Gutter Lip Ht (in)	N/A	N/A	Gutter X Slope (%)	N/A
N/A	Painted X Walk1?	No	N/A	Painted X Walk2?	No
	X Walk 1 Direction	To NW		X Walk 2 Direction	To SW
N/A	X Walk 1 Width (in)	N/A	N/A	X Walk 2 Width (in)	N/A
	X Walk 1 Slope (%)	5.4		X Walk 2 Slope (%)	1.1
	X Walk 1 X Slope (%)	4.4		X Walk 2 X Slope (%)	6.2

N/A	Ramp inside XWalk1?	N/A	N/A	Ramp inside XWalk2?	N/A
	Road Slope (%)	5.6	N/A	Clear Space?	N/A
	Road X Slope (%)	3.3	N/A	Clear Space to XWalk (in)	N/A
N/A	Any Obstructions?	N/A	N/A	Storm Grate/Utility Hazard?	N/A
	Obstruction Type			Storm Grate/Utility Type	
		N/A			N/A
			Yes	Surface Condition? (G/P)	Good

**Remove & Replace Curb Ramp With Two New Directional Ramps or Equivalent.**
