Access Compliance Report Public Rights-of-Way (Curb Ramps)

Intersection ID: 42470 Main Street: DUKE_LANCASTER_DR Cross Street: CASTLE_WATCH_AV Location: SW

ADA ID: F9C37C414060 Ramp Type: PerpDiag Initial Pass/Fail: Fail Overall Compliance: No Severity Score: 33.75

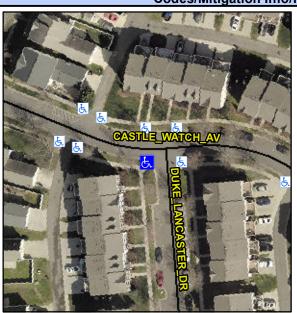
| Field Measurements/Component Compliance | | | | | | | |
|---|---|--|---|---|---|---|---|
| | N/A | Ramp Length (in) | 109.0 | No | Ramp | Slope (%) | 10.1 |
| | No | Ramp Width (in) | 38.0 | No | Ramp | XSlope (%) | 6.0 |

Remove & Replace Curb Ramp With Two New Directional Ramps or Equivalent.

R304.5.1, R304.2.2, R304.5.3
