# Access Compliance Report

## Public Rights-of-Way

### (Curb Ramps)

Intersection ID: 10028342	Main Street: HEYDON_PARK_WY	Cross Street: N/A	Location: NE
ADA ID: FA0012C94CA7	Ramp Type: Perp	Initial Pass/Fail: Fail	Overall Compliance: No Severity Score: 13.75

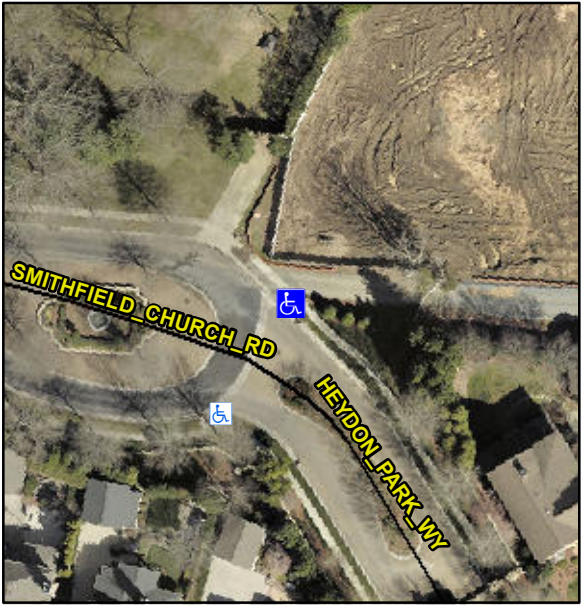
Possible Solutions:		<b>Compliance</b>	<b>Description</b>	<b>Data</b>
	<b>Remove &amp; Replace Entire Ramp.</b>		N/A	Ramp Length (in)	48.5
			Yes	Ramp Width (in)	48.0
			N/A	Flare Type LT	N/A
			N/A	Flare Slope LT (%)	N/A
			N/A	Flare Traversable LT?	N/A
			N/A	Landing Length (in)	N/A
			N/A	Landing Width (in)	N/A
			N/A	Landing Slope (%)	N/A
			N/A	Landing X Slope (%)	N/A
<p>Surveyor Notes:</p> <p><b>N/A</b></p> <p>PROW/ADA:</p> <p><b>R304.2.2, R304.5.3</b></p>			N/A	Flare Type RT	N/A
			N/A	Flare Slope RT (%)	N/A
			N/A	Flare Traversable RT?	N/A
			N/A	DWS Provided?	N/A
			N/A	DWS Contrast?	N/A
			N/A	DWS Length (in)	N/A
			N/A	DWS Full Width?	N/A
			N/A	DWS Offset (in)	N/A
			N/A	Shared Landing?	N/A
			N/A	Gutter Ponding?	N/A
			N/A	Gutter Lip Ht (in)	N/A
			N/A	Painted X Walk1?	No
				X Walk 1 Direction	To SW
			N/A	X Walk 1 Width (in)	N/A

X Walk 1 Slope (%)	0.5
				X Walk 1 X Slope (%)	1.5
			N/A	Ramp inside XWalk1?	N/A
				Road Slope (%)	N/A
				Road X Slope (%)	N/A
			N/A	Any Obstructions?	N/A
				Obstruction Type	
Total Cost:		\$ 1850.00			
			N/A		N/A
			Yes	Surface Condition? (G/P)	Good
