# Access Compliance Report

## Public Rights-of-Way

### (Curb Ramps)

Intersection ID: 4677	Main Street: OLD_STATESVILLE_RD	Cross Street: HENDERSON_RD	Location: E
ADA ID: FA36BC2D59EB	Ramp Type: Perp	Initial Pass/Fail: Fail	Overall Compliance: No
			Severity Score: 33.75

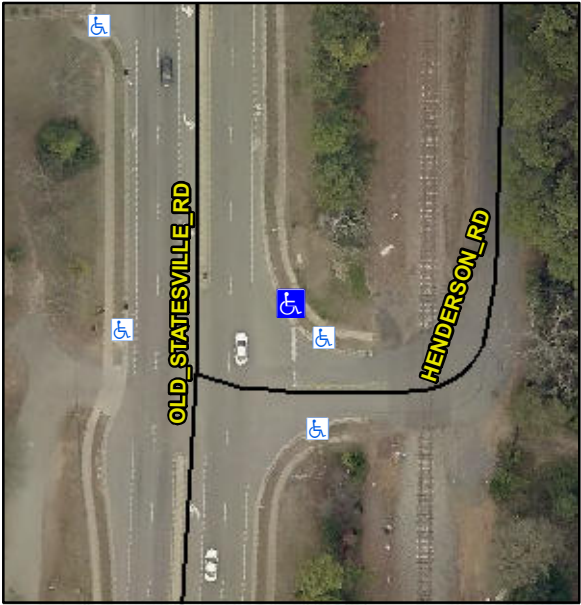
Possible Solutions:		<b>Compliance</b>	<b>Description</b>	<b>Data</b>	
	<b>Remove &amp; Replace Entire Ramp.</b>		<b>N/A</b>	Ramp Length (in)	<b>60.0</b>	<b>No</b>
			<b>No</b>	Ramp Width (in)	<b>45.0</b>	<b>Yes</b>
			<b>N/A</b>	Flare Type LT	<b>N/A</b>	<b>N/A</b>
			<b>N/A</b>	Flare Slope LT (%)	<b>N/A</b>	<b>N/A</b>
			<b>N/A</b>	Flare Traversable LT?	<b>N/A</b>	<b>N/A</b>
			<b>N/A</b>	Landing Length (in)	<b>N/A</b>	<b>N/A</b>
			<b>N/A</b>	Landing Width (in)	<b>N/A</b>	<b>N/A</b>
			<b>N/A</b>	Landing Slope (%)	<b>N/A</b>	<b>N/A</b>
			<b>N/A</b>	Landing X Slope (%)	<b>N/A</b>	<b>N/A</b>
			<b>N/A</b>	Landing Curb? (Y/N)	<b>N/A</b>	<b>N/A</b>
			<b>N/A</b>	Shared Landing?	<b>N/A</b>	
			<b>N/A</b>	Gutter Ponding?	<b>N/A</b>	<b>N/A</b>
			<b>N/A</b>	Gutter Lip Ht (in)	<b>N/A</b>	<b>N/A</b>
			<b>N/A</b>	Painted X Walk1?	<b>No</b>	<b>N/A</b>

X Walk 1 Direction	<b>To W</b>	
			<b>N/A</b>	X Walk 1 Width (in)	<b>N/A</b>	<b>N/A</b>
				X Walk 1 Slope (%)	<b>6.4</b>	
				X Walk 1 X Slope (%)	<b>2.6</b>	
			<b>N/A</b>	Ramp inside XWalk1?	<b>N/A</b>	<b>N/A</b>
<p>Surveyor Notes:</p> <p><b>N/A</b></p> <p>PROW/ADA:</p> <p><b>Not Found, R304.5.1, R304.2.2</b></p>			<b>N/A</b>	Road Slope (%)	<b>N/A</b>	<b>N/A</b>
			<b>N/A</b>	Road X Slope (%)	<b>N/A</b>	<b>N/A</b>
			<b>N/A</b>	Any Obstructions?	<b>N/A</b>	<b>N/A</b>
				Obstruction Type		
					<b>N/A</b>	<b>N/A</b>
			<b>Yes</b>	Surface Condition? (G/P)		<b>Good</b>
Total Cost:		\$ 1850.00
