## **Access Compliance Report Public Rights-of-Way** (Curb Ramps)

Intersection ID: 15139 Main Street: EAST BV **Cross Street: KENILWORTH AV** Location: **Overall Compliance: No ADA ID: FAC3681D3D88** Ramp Type: PerpDiag Initial Pass/Fail: Fail Severity Score: 26.25

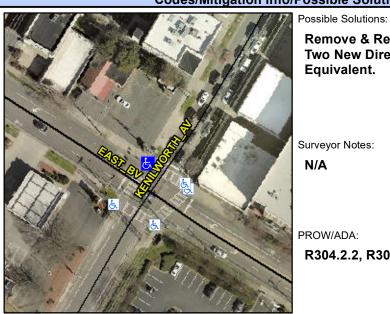
R304.2.2, R304.5.3

| Compliance Description | | Data | Comp | oliance Description | Data |
|---|---|---|---|---|---|
| N/A | Ramp Length (in) | 49.0 | No | Ramp Slope (%) | 13.7 |
| Yes | Ramp Width (in) | 48.0 | No | Ramp XSlope (%) | 3.5 |

**Remove & Replace Curb Ramp With Two New Directional Ramps or** Equivalent. Surveyor Notes:
