# Access Compliance Report

## Public Rights-of-Way

### (Curb Ramps)

Intersection ID: N/A	Main Street: PENCE_POND_LN	Cross Street: PENCE_RD	Location: SW
ADA ID: FAEB4DC8DB54	Ramp Type: Combination1	Initial Pass/Fail: Fail	Overall Compliance: No
Codes/Mitigation Info/Possible Solution			Severity Score: 10
			Field Measurements/Component Compliance

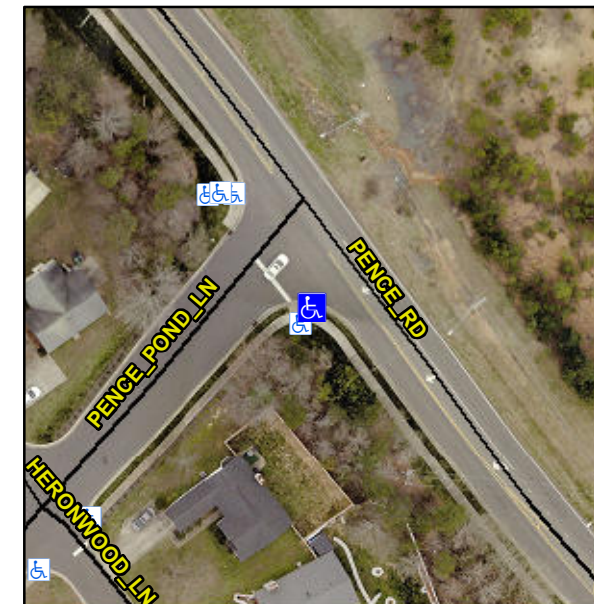
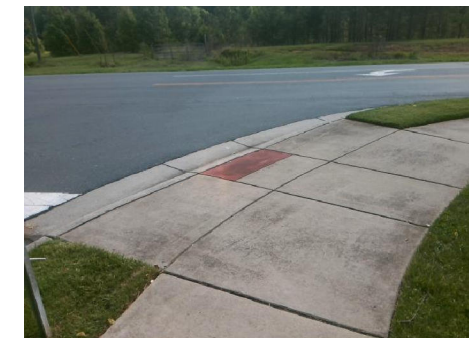
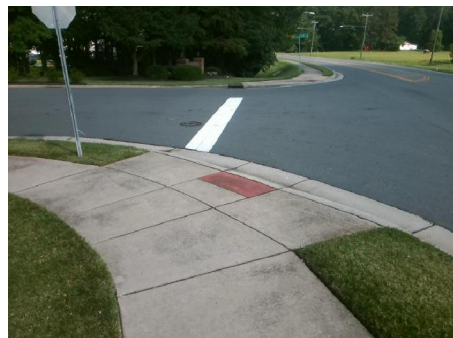
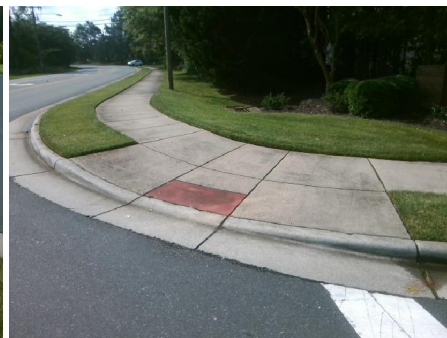
**RT RP < 5%**

**Not Found, R304.5.1, R304.5.3,  
R304.3.2, R304.2.1, R304.2.2-Perp,  
R304.3.2-Para, R302.7.2, R304.5.4**

Compliance	Description	Data	Compliance	Description	Data
N/A	Ramp Length LT (in)	42.0	N/A	Ramp Length RT (in)	50.0
Yes	Ramp Width LT (in)	59.5	Yes	Ramp Width RT (in)	59.5
No	Ramp Slope LT (%)	14.6	Yes	Ramp Slope RT (%)	2.1
No	Ramp XSlope LT (%)	3.5	No	Ramp XSlope RT (%)	3.3
N/A	Ramp Length (in)	107.0	Yes	Ramp Slope (%)	5.4
No	Ramp Width (in)	34.0	No	Ramp XSlope (%)	5.8
N/A	Flare Type LT	N/A	N/A	Flare Type RT	N/A
N/A	Flare Slope LT (%)	N/A	N/A	Flare Slope RT (%)	N/A
N/A	Flare Traversable LT?	No	N/A	Flare Traversable RT?	No
No	Landing Length (in)	N/A	N/A	DWS Provided?	N/A
No	Landing Width (in)	N/A	N/A	DWS Contrast?	N/A
No	Landing Slope (%)	N/A	N/A	DWS Length (in)	N/A
No	Landing X Slope (%)	N/A	N/A	DWS Full Width?	N/A
N/A	Landing Curb? (Y/N)	N/A	N/A	DWS Offset (in)	N/A
N/A	Shared Landing?	N/A			
Yes	Gutter Ponding?	N/A	No	Gutter Slope (%)	N/A
No	Gutter Lip Ht (in)	N/A	No	Gutter X Slope (%)	N/A
N/A	Painted X Walk1?	No	N/A	Painted X Walk2?	N/A

X Walk 1 Direction	To NW		X Walk 2 Direction	N/A
	X Walk 1 Width (in)	N/A		X Walk 2 Width (in)	N/A
	X Walk 1 Slope (%)	0.7		X Walk 2 Slope (%)	N/A
	X Walk 1 X Slope (%)	5.0		X Walk 2 X Slope (%)	N/A
N/A	Ramp inside XWalk1?	N/A	N/A	Ramp inside XWalk2?	N/A
	Road Slope (%)	N/A		Clear Space?	N/A
	Road X Slope (%)	N/A	N/A	Clear Space to XWalk (in)	N/A
			Yes	Any Obstruction?	N/A
				Obstruction Type	N/A
			Yes	Storm Grate/Utility Hazard?	N/A
				Storm Grate/Utility Type	N/A
			Yes	Surface Condition? (G/P)	Good
				Curb Slope (%)	16.1

**Remove & Replace Entire Ramp.  
Remove & Replace Gutter.**
