Access Compliance Report

Public Rights-of-Way

| Intersection ID: 24197 | Main Street: CHINA GROVE CHURCH RD | Cross Street: ERVIN LN | Location: SE |
| ADA ID: FB29F11BDFD0 | Ramp Type: PerpDiag | Initial Pass/Fail: Fail | Overall Compliance: No |

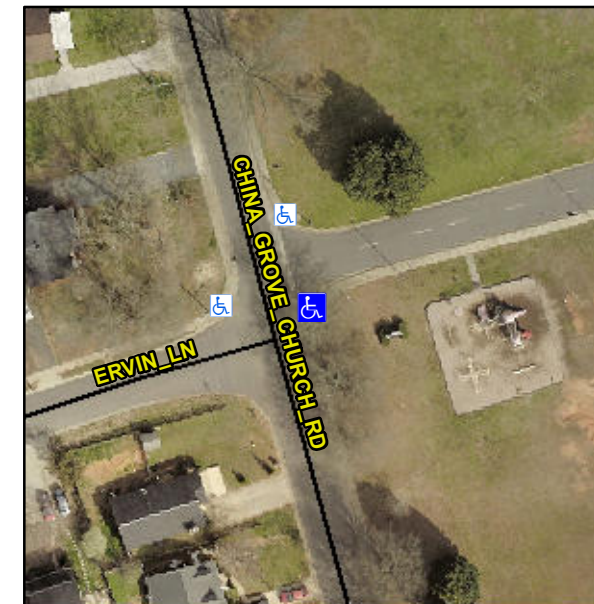
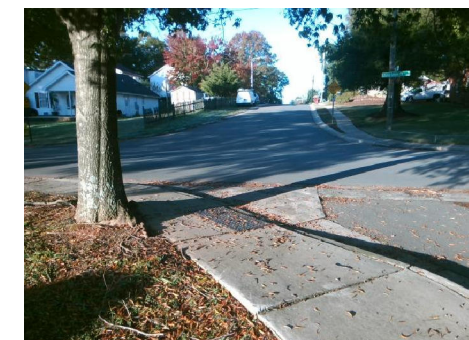
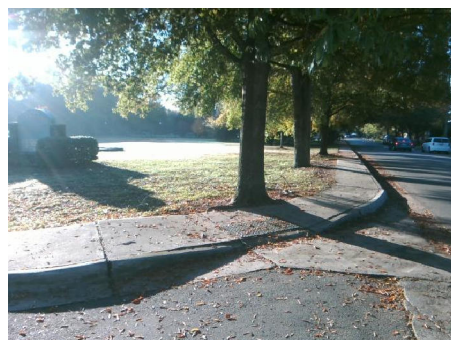
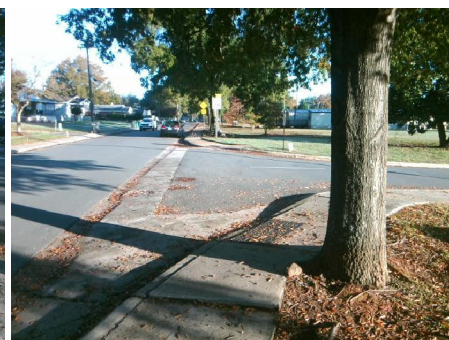
| | | Severity Score: 8.75 | |

Not Found, R304.5.1

| Compliance | Description | Data | Compliance | Description | Data |
|---|---|---|---|---|---|
| No | Ramp Width (in) | 41.0 | Yes | Ramp XSlope (%) | 1.9 |

Remove & Replace Curb Ramp With Two New Directional Ramps or Equivalent.

Total Cost: \$ 3200.00
