Access Compliance Report

Public Rights-of-Way

(Curb Ramps)

Intersection ID: 5758	Main Street: NEVIN_RD	Cross Street: SPANISH_MOSS_LN	Location: SE
ADA ID: FB5D4E0A42CD	Ramp Type: PerpDiag	Initial Pass/Fail: Fail	Overall Compliance: No
			Severity Score: 21.25

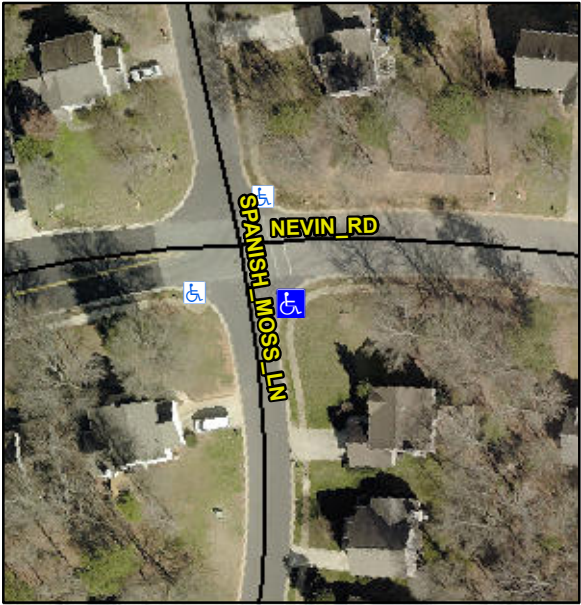
Possible Solutions:		Compliance	Description	Data
	Remove & Replace Curb Ramp With Two New Directional Ramps or Equivalent.		No	Ramp Length (in)	47.0
			No	Ramp Width (in)	41.5
			N/A	Flare Type LT	N/A
			N/A	Flare Slope LT (%)	N/A
			N/A	Flare Traversable LT?	N/A
			N/A	Landing Length (in)	N/A
			N/A	Landing Width (in)	N/A
			N/A	Landing Slope (%)	N/A
			N/A	Landing X Slope (%)	N/A
<p>Surveyor Notes:</p> <p>N/A</p> <p>PROW/ADA:</p> <p>Not Found, R304.5.1, R304.2.2</p>			N/A	Flare Type RT	N/A
			N/A	Flare Slope RT (%)	N/A
			N/A	Flare Traversable RT?	N/A
			N/A	DWS Provided?	N/A
			N/A	DWS Contrast?	N/A
			N/A	DWS Length (in)	N/A
			N/A	DWS Full Width?	N/A
			N/A	DWS Offset (in)	N/A
			N/A	Gutter Ponding?	N/A
			N/A	Gutter Lip Ht (in)	N/A
			N/A	Painted X Walk1?	Yes
				X Walk 1 Direction	To N
			N/A	X Walk 1 Width (in)	72.0
				X Walk 1 Slope (%)	2.7

X Walk 1 X Slope (%)	1.4
			N/A	Ramp inside XWalk1?	Yes
				Road Slope (%)	2.2
				Road X Slope (%)	7.6
			N/A	Any Obstructions?	N/A
				Obstruction Type	
Total Cost:					\$ 3200.00
			N/A		N/A
			Yes	Surface Condition? (G/P)	Good
