# Access Compliance Report

## Public Rights-of-Way

### (Curb Ramps)

Intersection ID: 50608	Main Street: DENBUR_DR	Cross Street: DOWNY_BIRCH_RD	Location: SE
ADA ID: FB72CE107FAA	Ramp Type: Perp	Initial Pass/Fail: Pass	Overall Compliance: No
Severity Score: 5.25			
Codes/Mitigation Info/Possible Solution		Field Measurements/Component Compliance

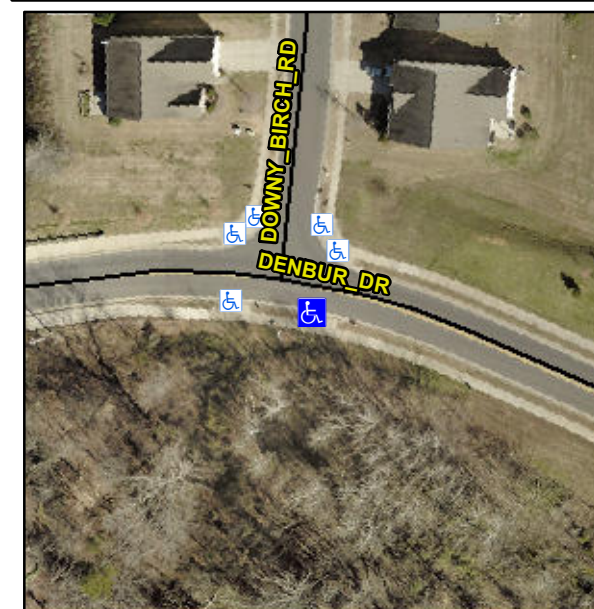
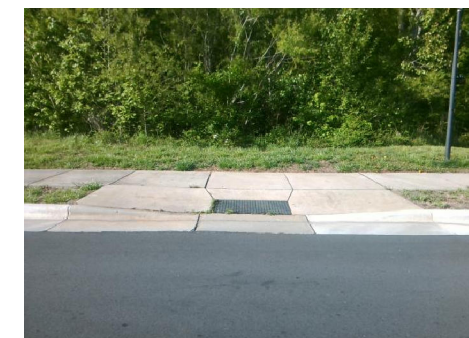
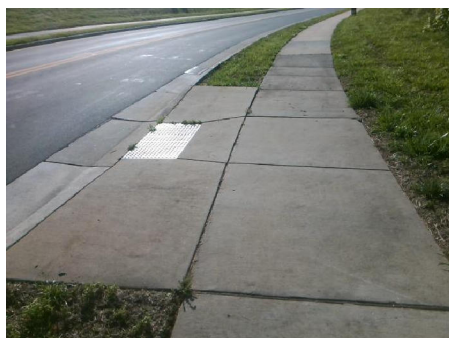
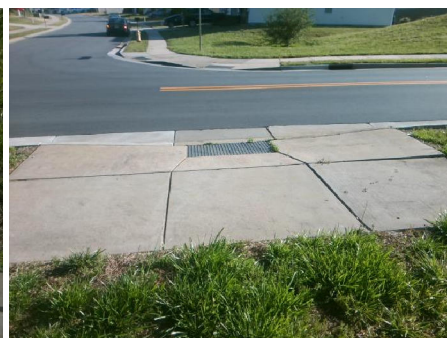
**Not Found, R304.5.3, R304.5.4**

Compliance	Description	Data	Compliance	Description	Data
N/A	Ramp Length (in)	47.0	Yes	Ramp Slope (%)	5.6
Yes	Ramp Width (in)	48.0	No	Ramp XSlope (%)	4.2
N/A	Flare Type LT	Sloped	N/A	Flare Type RT	N/A
N/A	Flare Slope LT (%)	6.6	Yes	Flare Slope RT (%)	2.0
N/A	Flare Traversable LT?	Yes	N/A	Flare Traversable RT?	Yes
Yes	Landing Length (in)	60.0	Yes	DWS Provided?	Yes
Yes	Landing Width (in)	62.0	Yes	DWS Contrast?	Yes
Yes	Landing Slope (%)	0.8	Yes	DWS Length (in)	24.0
No	Landing X Slope (%)	3.1	Yes	DWS Full Width?	Yes
N/A	Landing Curb? (Y/N)	No	Yes	DWS Offset (in)	0.0
N/A	Shared Landing?	No			
Yes	Gutter Ponding?	No	No	Gutter Slope (%)	5.2
Yes	Gutter Lip Ht (in)	0.0	No	Gutter X Slope (%)	4.0
N/A	Painted X Walk1?	No	N/A	Painted X Walk2?	N/A
	X Walk 1 Direction	To N		X Walk 2 Direction	N/A
N/A	X Walk 1 Width (in)	N/A	N/A	X Walk 2 Width (in)	N/A
	X Walk 1 Slope (%)	1.0		X Walk 2 Slope (%)	N/A
	X Walk 1 X Slope (%)	2.6		X Walk 2 X Slope (%)	N/A

N/A	Ramp inside XWalk1?	N/A	N/A	Ramp inside XWalk2?	N/A
	Road Slope (%)	N/A	N/A	Clear Space?	Yes
	Road X Slope (%)	N/A	N/A	Clear Space to XWalk (in)	N/A
Yes	Any Obstructions?	No	Yes	Storm Grate/Utility Hazard?	No
	Obstruction Type			Storm Grate/Utility Type	
		N/A			N/A
			Yes	Surface Condition? (G/P)	Good

**Remove & Replace Entire Ramp.  
Remove & Replace Gutter.**
