Access Compliance Report

Public Rights-of-Way

(Curb Ramps)

Intersection ID: 11226	Main Street: AIRLIE_ST	Cross Street: EASTWOOD_DR	Location:	N
ADA ID: FBEBEBBB5875	Ramp Type: Perp	Initial Pass/Fail: Fail	Overall Compliance: No	Severity Score: 22.5

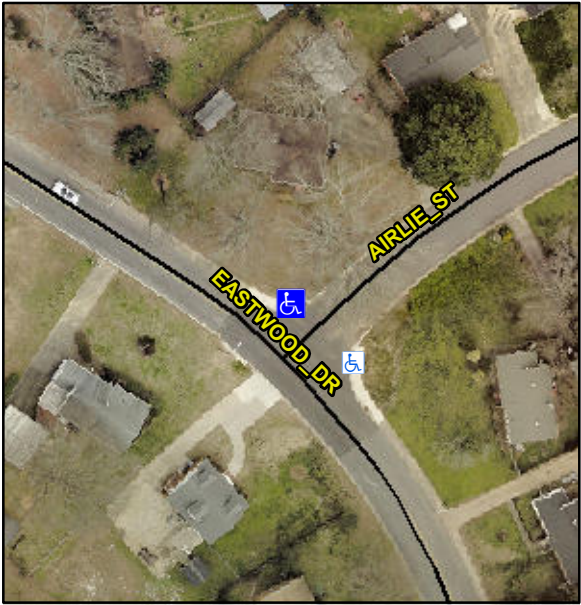
Possible Solutions:		Compliance	Description	Data
	Remove & Replace Entire Ramp.		No	Ramp Length (in)	55.5
			No	Ramp Width (in)	47.0
			N/A	Flare Type LT	N/A
			N/A	Flare Slope LT (%)	N/A
			N/A	Flare Traversable LT?	N/A
			N/A	Landing Length (in)	N/A
			N/A	Landing Width (in)	N/A
			N/A	Landing Slope (%)	N/A
			N/A	Landing X Slope (%)	N/A
<p>Surveyor Notes:</p> <p>N/A</p> <p>PROW/ADA:</p> <p>Not Found, R304.5.1, R304.2.2, R304.5.3</p>			N/A	Flare Type RT	N/A
			N/A	Flare Slope RT (%)	N/A
			N/A	Flare Traversable RT?	N/A
			N/A	DWS Provided?	N/A
			N/A	DWS Contrast?	N/A
			N/A	DWS Length (in)	N/A
			N/A	DWS Full Width?	N/A
			N/A	DWS Offset (in)	N/A
			N/A	Gutter Ponding?	N/A
			N/A	Gutter Lip Ht (in)	N/A
			No	Painted X Walk1?	N/A
				X Walk 1 Direction	To SE
			N/A	X Walk 1 Width (in)	N/A
				X Walk 1 Slope (%)	1.7
				X Walk 1 X Slope (%)	1.6
