Access Compliance Report

Public Rights-of-Way (Curb Ramps)

| Intersection ID: 20800 | Main Street: HILLSTONE_CT | Cross Street: SANDY_PORTER_RD | Location: SW |
| ADA ID: FC3517156906 | Ramp Type: Directional1 | Initial Pass/Fail: Fail | Overall Compliance: No |

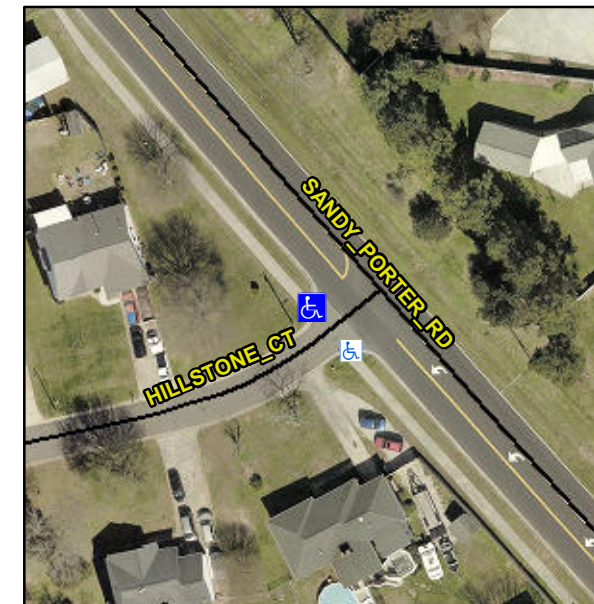
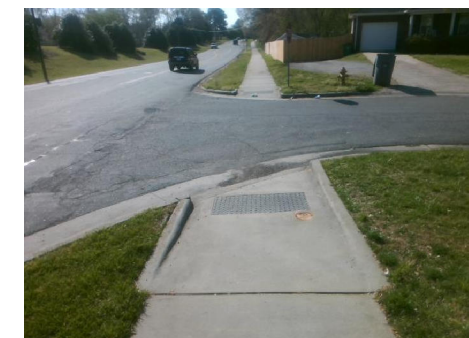
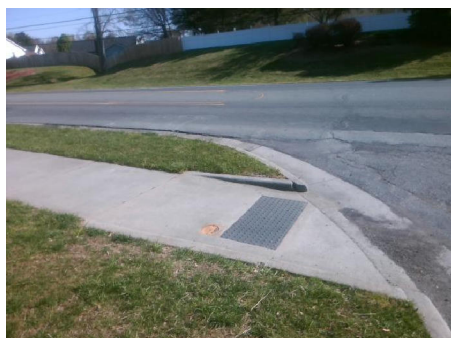
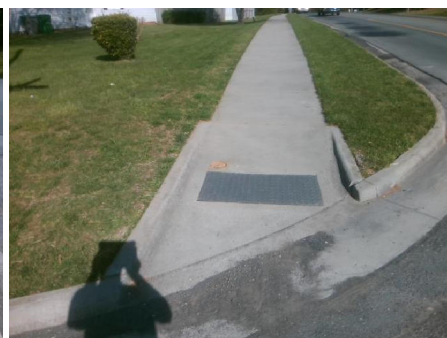
R304.5.3

| Compliance | Description | Data | Compliance | Description | Data |
|---|---|---|---|---|---|
| No | Ramp XSlope (%) | 2.6 | | | |

Remove & Replace Entire Ramp.
