Access Compliance Report

Public Rights-of-Way

(Curb Ramps)

Intersection ID: 26242	Main Street: BAYBROOK_LN	Cross Street: BEVINGTON_PL	Location: SW
ADA ID: FD03A84B926E	Ramp Type: PerpDiag	Initial Pass/Fail: Fail	Overall Compliance: No
			Severity Score: 21.25

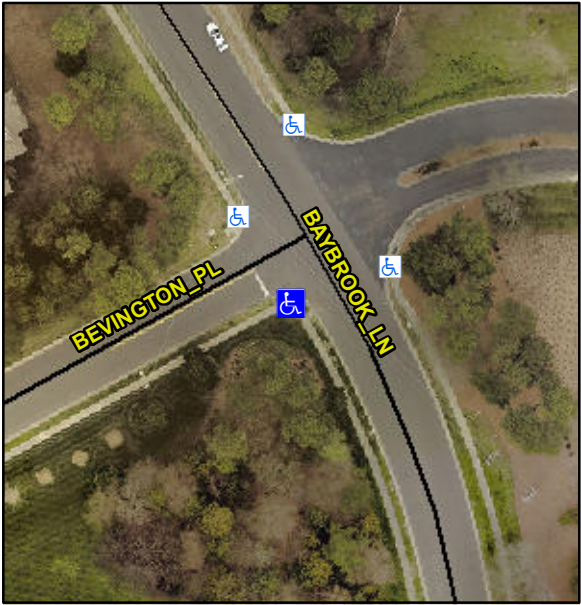
Possible Solutions:		Compliance	Description	Data
	Remove & Replace Curb Ramp With Two New Directional Ramps or Equivalent.		No	Ramp Length (in)	68.0
			No	Ramp Width (in)	47.0
			N/A	Flare Type LT	N/A
			N/A	Flare Slope LT (%)	N/A
			N/A	Flare Traversable LT?	N/A
			N/A	Landing Length (in)	N/A
			N/A	Landing Width (in)	N/A
			N/A	Landing Slope (%)	N/A
			N/A	Landing X Slope (%)	N/A
<p>Surveyor Notes:</p> <p>N/A</p> <p>PROW/ADA:</p> <p>R304.5.1, R304.2.2</p>			N/A	Flare Type RT	N/A
			N/A	Flare Slope RT (%)	N/A
			N/A	Flare Traversable RT?	N/A
			N/A	DWS Provided?	N/A
			N/A	DWS Contrast?	N/A
			N/A	DWS Length (in)	N/A
			N/A	DWS Full Width?	N/A
			N/A	DWS Offset (in)	N/A
			N/A	Shared Landing?	N/A
			N/A	Gutter Ponding?	N/A
			N/A	Gutter Lip Ht (in)	N/A
			N/A	Painted X Walk1?	No
				X Walk 1 Direction	To NE
			N/A	X Walk 1 Width (in)	N/A

X Walk 1 Slope (%)	4.1
				X Walk 1 X Slope (%)	0.4
			N/A	Ramp inside XWalk1?	N/A
				Road Slope (%)	1.7
				Road X Slope (%)	1.9
			N/A	Any Obstructions?	N/A
				Obstruction Type	
Total Cost:		\$ 3200.00			
			N/A		N/A
			Yes	Surface Condition? (G/P)	Good
