Access Compliance Report

Public Rights-of-Way

(Curb Ramps)

Intersection ID: 52531	Main Street: WILSHIRE_PL	Cross Street: BAMBOO_ST	Location: SE
ADA ID: FD19505EF285	Ramp Type: Perp	Initial Pass/Fail: Fail	Overall Compliance: No
		Severity Score: 1.25

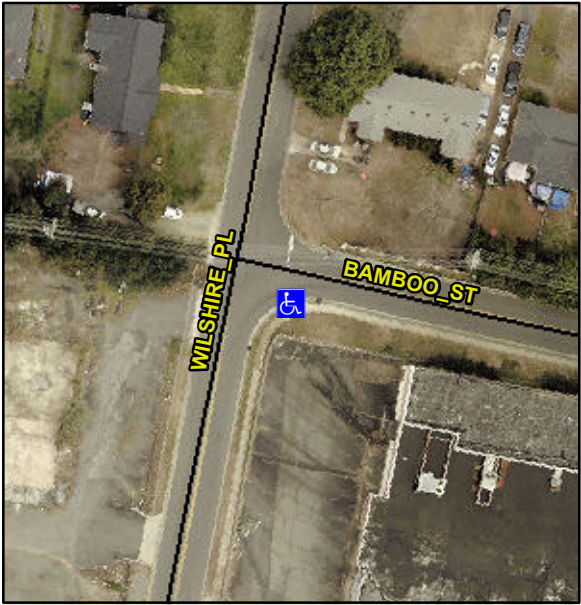
Possible Solutions:		Compliance	Description	Data
	Remove & Replace Entire Ramp.		N/A	Ramp Length (in)	87.0
			Yes	Ramp Width (in)	53.0
			N/A	Flare Type LT	N/A
			N/A	Flare Slope LT (%)	N/A
			N/A	Flare Traversable LT?	N/A
			N/A	Landing Length (in)	N/A
			N/A	Landing Width (in)	N/A
			N/A	Landing Slope (%)	N/A
			N/A	Landing X Slope (%)	N/A
<p>Surveyor Notes:</p> <p>N/A</p> <p>PROW/ADA:</p> <p>R304.5.3</p>			N/A	Flare Type RT	N/A
			N/A	Flare Slope RT (%)	N/A
			N/A	Flare Traversable RT?	N/A
			N/A	DWS Provided?	N/A
			N/A	DWS Contrast?	N/A
			N/A	DWS Length (in)	N/A
			N/A	DWS Full Width?	N/A
			N/A	DWS Offset (in)	N/A
			N/A	Shared Landing?	N/A
			N/A	Gutter Ponding?	N/A
			N/A	Gutter Lip Ht (in)	N/A
			N/A	Painted X Walk1?	No
				X Walk 1 Direction	To N
			N/A	X Walk 1 Width (in)	N/A
				X Walk 1 Slope (%)	1.8
				X Walk 1 X Slope (%)	1.9
