# Access Compliance Report

## Public Rights-of-Way

### (Curb Ramps)

Intersection ID: 26681	Main Street: COUNTRY_LN	Cross Street: LOMA_LINDA_LN	Location: SW
ADA ID: FD7474A22B38	Ramp Type: Perp	Initial Pass/Fail: Fail	Overall Compliance: No
Severity Score: 8.75			
Codes/Mitigation Info/Possible Solution		Field Measurements/Component Compliance

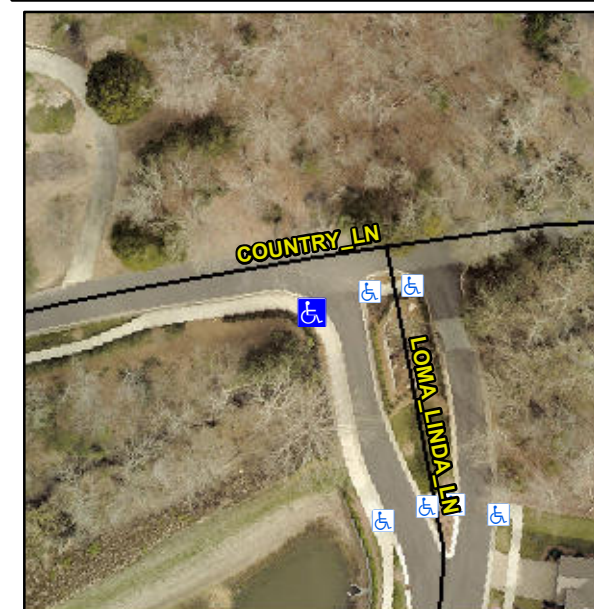
**Not Found, R304.5.1**

Compliance	Description	Data	Compliance	Description	Data
N/A	Ramp Length (in)	85.0	Yes	Ramp Slope (%)	7.8
No	Ramp Width (in)	44.5	Yes	Ramp XSlope (%)	0.1
N/A	Flare Type LT	N/A	N/A	Flare Type RT	N/A
N/A	Flare Slope LT (%)	N/A	N/A	Flare Slope RT (%)	N/A
N/A	Flare Traversable LT?	N/A	N/A	Flare Traversable RT?	N/A
N/A	Landing Length (in)	N/A	N/A	DWS Provided?	N/A
N/A	Landing Width (in)	N/A	N/A	DWS Contrast?	N/A
N/A	Landing Slope (%)	N/A	N/A	DWS Length (in)	N/A
N/A	Landing X Slope (%)	N/A	N/A	DWS Full Width?	N/A
N/A	Landing Curb? (Y/N)	N/A	N/A	DWS Offset (in)	N/A
N/A	Shared Landing?	N/A			
N/A	Gutter Ponding?	N/A	N/A	Gutter Slope (%)	N/A
N/A	Gutter Lip Ht (in)	N/A	N/A	Gutter X Slope (%)	N/A
N/A	Painted X Walk1?	No	N/A	Painted X Walk2?	N/A
	X Walk 1 Direction	To E		X Walk 2 Direction	N/A
N/A	X Walk 1 Width (in)	N/A	N/A	X Walk 2 Width (in)	N/A
	X Walk 1 Slope (%)	1.0		X Walk 2 Slope (%)	N/A
	X Walk 1 X Slope (%)	0.4		X Walk 2 X Slope (%)	N/A

**Remove & Replace Entire Ramp.**

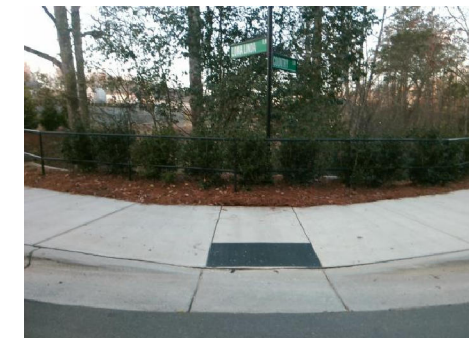
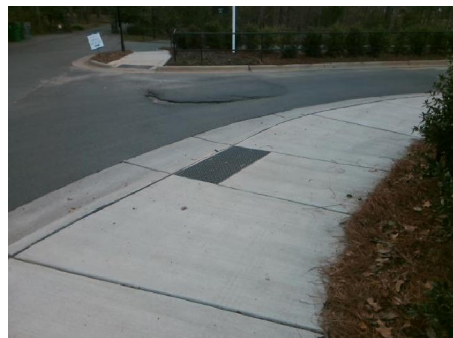
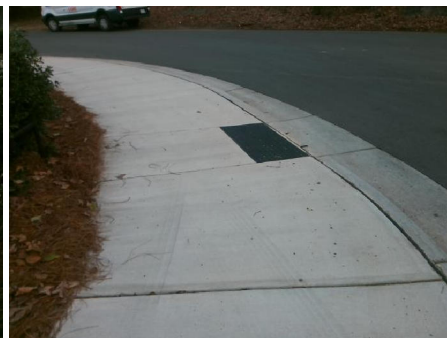
N/A	Ramp inside XWalk1?	N/A	N/A	Ramp inside XWalk2?	N/A
	Road Slope (%)	N/A	N/A	Clear Space?	N/A
	Road X Slope (%)	N/A	N/A	Clear Space to XWalk (in)	N/A
N/A	Any Obstructions?	N/A	N/A	Storm Grate/Utility Hazard?	N/A
	Obstruction Type			Storm Grate/Utility Type	
		N/A			N/A
		Yes		Surface Condition? (G/P)	Good
