Access Compliance Report

Public Rights-of-Way

| Intersection ID: 47499 | Main Street: STACCATO_ST | Cross Street: BEVERLY_CREST_BV | Location: NE |
| ADA ID: FD78DAF39F1B | Ramp Type: Perp | Initial Pass/Fail: Fail | Overall Compliance: No |

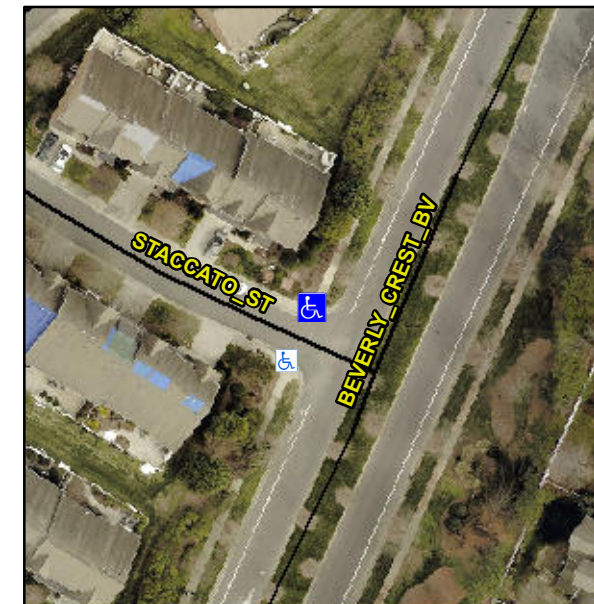
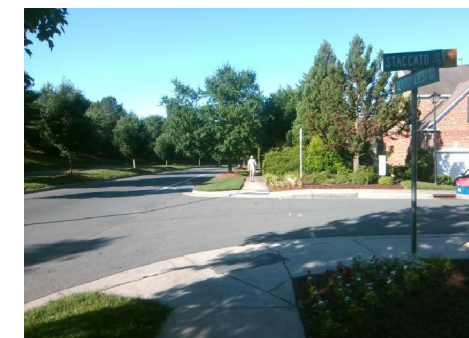
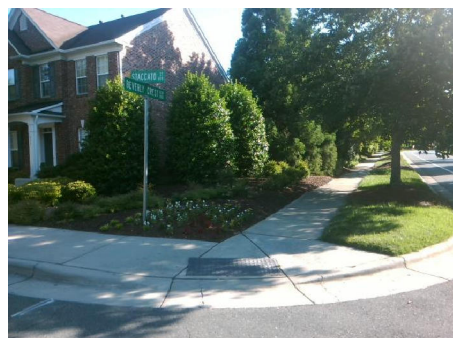
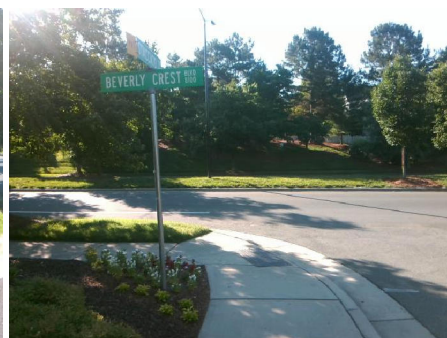
Not Found, R304.5.1, R304.5.3

| Compliance | Description | Data | Compliance | Description | Data |
|---|---|---|---|---|---|
| N/A | Ramp Length (in) | 55.0 | Yes | Ramp Slope (%) | 6.3 |
| No | Ramp Width (in) | 35.0 | No | Ramp XSlope (%) | 3.6 |

Remove & Replace Entire Ramp.
