Access Compliance Report

Public Rights-of-Way

(Curb Ramps)

Intersection ID: 52112	Main Street: YOUNGBLOOD_ST	Cross Street: POINDEXTER_DR	Location: S
ADA ID: FD9CC15098C1	Ramp Type: Perp	Initial Pass/Fail: Fail	Overall Compliance: No
Severity Score: 12.5			
Codes/Mitigation Info/Possible Solution		Field Measurements/Component Compliance

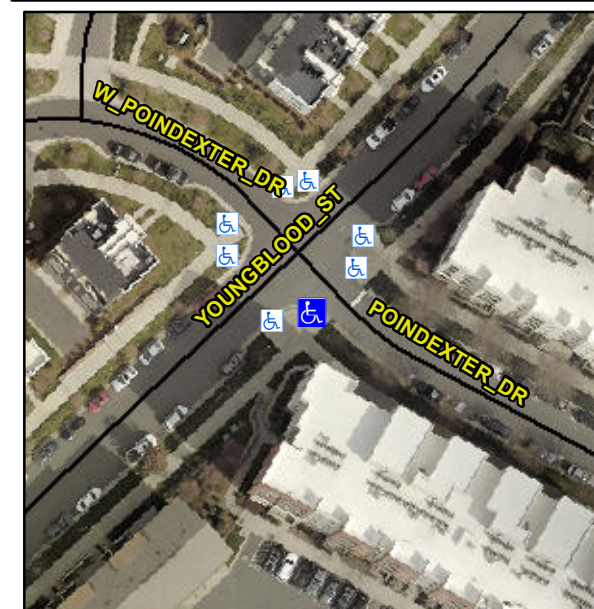
Not Found, R304.2.2

Compliance	Description	Data	Compliance	Description	Data
N/A	Ramp Length (in)	75.0	No	Ramp Slope (%)	10.2
Yes	Ramp Width (in)	48.0	Yes	Ramp XSlope (%)	0.8
N/A	Flare Type LT	N/A	N/A	Flare Type RT	N/A
N/A	Flare Slope LT (%)	N/A	N/A	Flare Slope RT (%)	N/A
N/A	Flare Traversable LT?	N/A	N/A	Flare Traversable RT?	N/A
N/A	Landing Length (in)	N/A	N/A	DWS Provided?	N/A
N/A	Landing Width (in)	N/A	N/A	DWS Contrast?	N/A
N/A	Landing Slope (%)	N/A	N/A	DWS Length (in)	N/A
N/A	Landing X Slope (%)	N/A	N/A	DWS Full Width?	N/A
N/A	Landing Curb? (Y/N)	N/A	N/A	DWS Offset (in)	N/A
N/A	Shared Landing?	N/A			
N/A	Gutter Ponding?	N/A	N/A	Gutter Slope (%)	N/A
N/A	Gutter Lip Ht (in)	N/A	N/A	Gutter X Slope (%)	N/A
N/A	Painted X Walk1?	No	N/A	Painted X Walk2?	N/A
	X Walk 1 Direction	To NE		X Walk 2 Direction	N/A
N/A	X Walk 1 Width (in)	N/A	N/A	X Walk 2 Width (in)	N/A
	X Walk 1 Slope (%)	1.4		X Walk 2 Slope (%)	N/A
	X Walk 1 X Slope (%)	2.5		X Walk 2 X Slope (%)	N/A

Remove & Replace Entire Ramp.

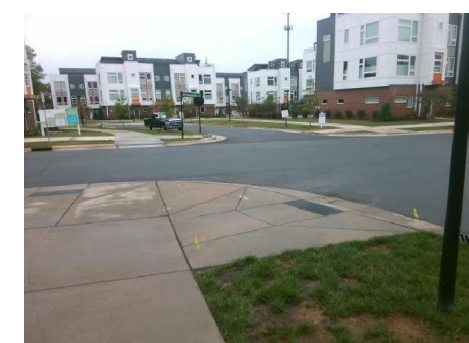
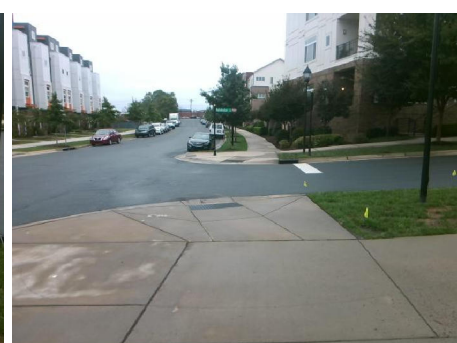
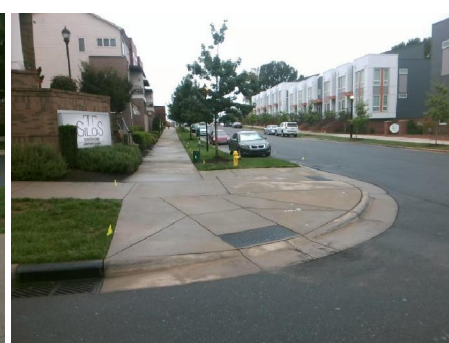
N/A	Ramp inside XWalk1?	N/A	N/A	Ramp inside XWalk2?	N/A
	Road Slope (%)	N/A	N/A	Clear Space?	N/A
	Road X Slope (%)	N/A	N/A	Clear Space to XWalk (in)	N/A
N/A	Any Obstructions?	N/A	N/A	Storm Grate/Utility Hazard?	N/A
	Obstruction Type			Storm Grate/Utility Type	
		N/A			N/A
			Yes	Surface Condition? (G/P)	Good
