Intersection ID: N/A	Main Street: ELGIN_MOOR_RD	Cross Street: DOUGLAS_PALACE_CT	Location:	NW
ADA ID: FDB7ECB5AA64	Ramp Type: Perp	Initial Pass/Fail: Fail	Overall Compliance: No	Severity Score: 21.25

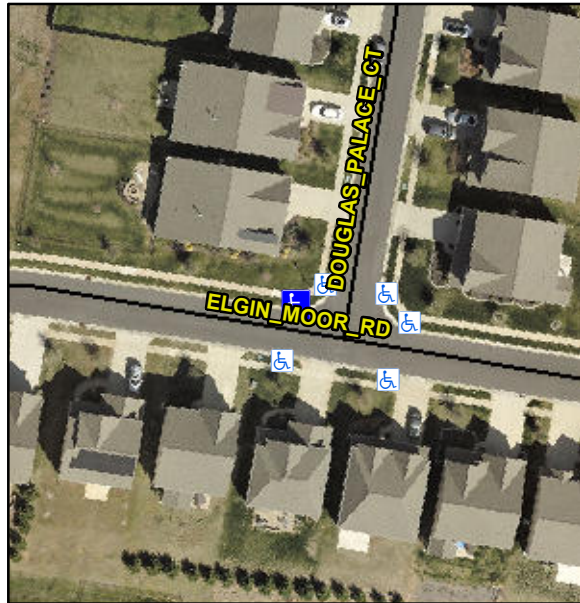
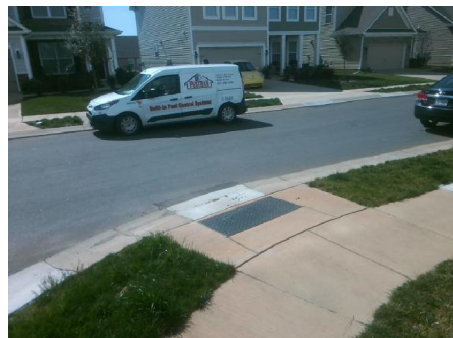
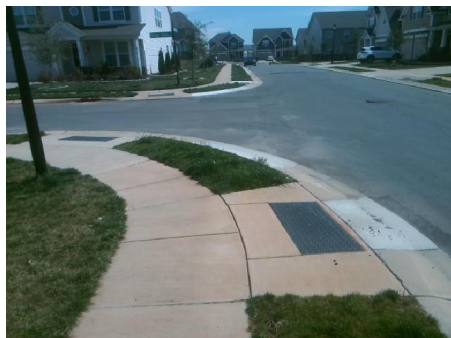
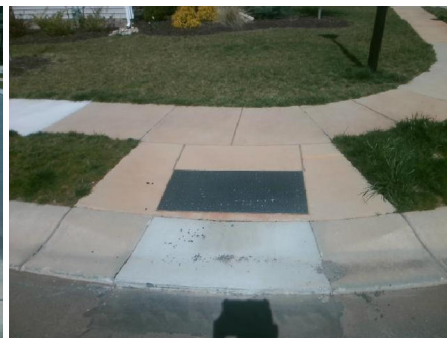
**Not Found, R304.5.1, R304.2.2**

Possible Solutions:			Compliance	Description	Data	Compliance	Description	Data
<b>Remove &amp; Replace Entire Ramp.</b>			N/A	Ramp Length (in)	47.0	No	Ramp Slope (%)	9.8
			No	Ramp Width (in)	47.0	Yes	Ramp XSlope (%)	1.1
			N/A	Flare Type LT	N/A	N/A	Flare Type RT	N/A
			N/A	Flare Slope LT (%)	N/A	N/A	Flare Slope RT (%)	N/A
			N/A	Flare Traversable LT?	N/A	N/A	Flare Traversable RT?	N/A
			N/A	Landing Length (in)	N/A	N/A	DWS Provided?	N/A
			N/A	Landing Width (in)	N/A	N/A	DWS Contrast?	N/A
			N/A	Landing Slope (%)	N/A	N/A	DWS Length (in)	N/A
			N/A	Landing X Slope (%)	N/A	N/A	DWS Full Width?	N/A
			N/A	Landing Curb? (Y/N)	N/A	N/A	DWS Offset (in)	N/A
Surveyor Notes:			N/A	Shared Landing?	N/A			
<b>Not Found, R304.5.1, R304.2.2</b>			N/A	Gutter Ponding?	N/A	N/A	Gutter Slope (%)	N/A
			N/A	Gutter Lip Ht (in)	1.0	N/A	Gutter X Slope (%)	N/A
			N/A	Painted X Walk1?	No	N/A	Painted X Walk2?	N/A
				X Walk 1 Direction	To SW		X Walk 2 Direction	N/A

### Remove & Replace Entire Ramp.
