# Access Compliance Report

## Public Rights-of-Way

| Intersection ID: 44486 | Main Street: NEWFIELD_ST | Cross Street: DARWICK_ST | Location: SE |
| ADA ID: FDC3EE514DBC | Ramp Type: PerpDiag | Initial Pass/Fail: Fail | Overall Compliance: No |

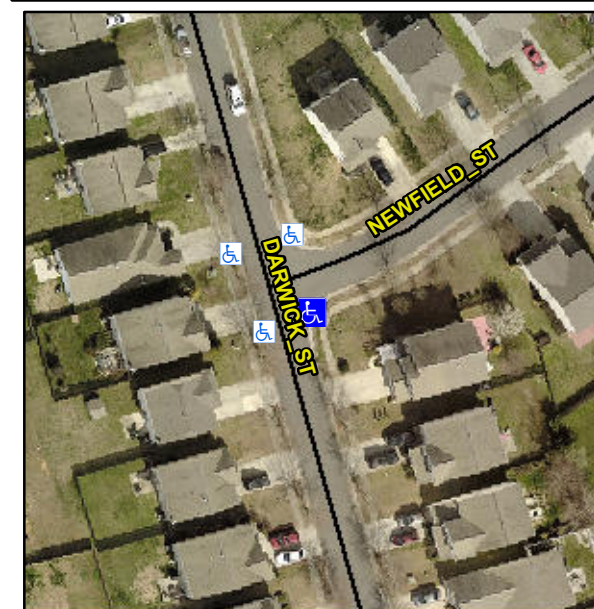
| Severity Score: 8.75 | | | |

**Not Found, R304.5.1**

| Compliance | Description | Data | Compliance | Description | Data |
|---|---|---|---|---|---|
| No | Ramp Width (in) | 47.5 | Yes | Ramp XSlope (%) | 1.2 |

**Remove & Replace Curb Ramp With Two New Directional Ramps or Equivalent.**

Total Cost: \$ 3200.00
