Access Compliance Report

Public Rights-of-Way

(Curb Ramps)

| Intersection ID: 8573 | Main Street: N_GRAHAM_ST | Cross Street: ATANDO_AV | Location: SE |

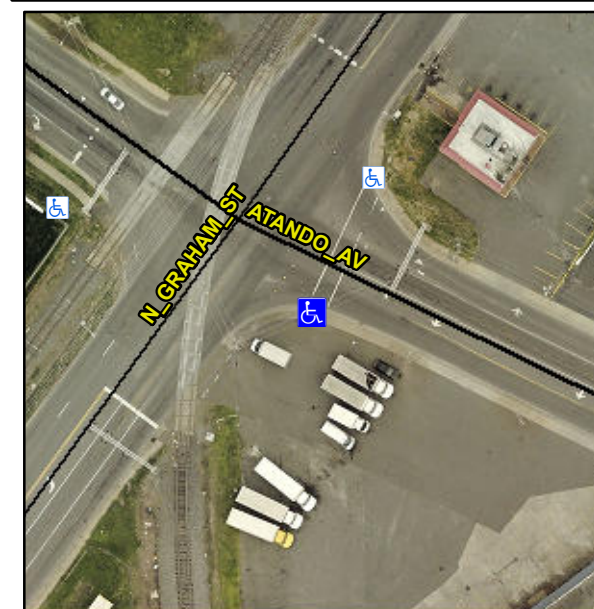
| ADA ID: FDFC3C5F1F48 | Ramp Type: Para | Initial Pass/Fail: Fail | Overall Compliance: No |

R304.5.3

| Compliance | Description | Data | Compliance | Description | Data |
|---|---|---|---|---|---|
| No | Ramp XSlope LT (%) | 5.2 | No | Ramp XSlope RT (%) | 3.5 |

Remove & Replace Entire Ramp.
