Access Compliance Report

Public Rights-of-Way

(Curb Ramps)

Intersection ID: 11878	Main Street: MIMOSA_AV	Cross Street: THE_PLAZA	Location: SW
ADA ID: FDFD9A9ED327	Ramp Type: Perp	Initial Pass/Fail: Fail	Overall Compliance: No
		Severity Score: 1.25

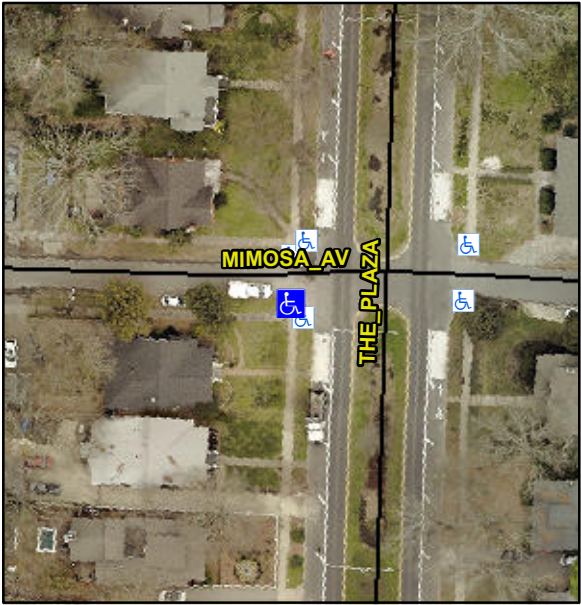
Possible Solutions:		Compliance	Description	Data
	Remove & Replace Entire Ramp.		N/A	Ramp Length (in)	72.0
			Yes	Ramp Width (in)	56.0
			N/A	Flare Type LT	N/A
			N/A	Flare Slope LT (%)	N/A
			N/A	Flare Traversable LT?	N/A
			N/A	Landing Length (in)	N/A
			N/A	Landing Width (in)	N/A
			N/A	Landing Slope (%)	N/A
			N/A	Landing X Slope (%)	N/A
<p>Surveyor Notes:</p> <p>N/A</p> <p>PROW/ADA:</p> <p>Not Found, R304.5.3</p>			N/A	Flare Type RT	N/A
			N/A	Flare Slope RT (%)	N/A
			N/A	Flare Traversable RT?	N/A
			N/A	DWS Provided?	N/A
			N/A	DWS Contrast?	N/A
			N/A	DWS Length (in)	N/A
			N/A	DWS Full Width?	N/A
			N/A	DWS Offset (in)	N/A
			N/A	Shared Landing?	N/A
			N/A	Gutter Ponding?	N/A
			N/A	Gutter Lip Ht (in)	N/A
			N/A	Painted X Walk1?	No
				X Walk 1 Direction	To N
			N/A	X Walk 1 Width (in)	N/A
				X Walk 1 Slope (%)	1.7
				X Walk 1 X Slope (%)	1.9
