Access Compliance Report Public Rights-of-Way (Curb Ramps)

Intersection ID: N/A Main Street: ELGIN_MOOR_RD **Cross Street: LANGWELL_LN** Location: SE ADA ID: FE066DC71A9F Ramp Type: Perp Initial Pass/Fail: Fail **Overall Compliance: No Severity Score:** 8.75

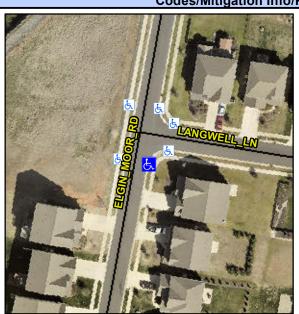
/Possible Solution			Field Measurements/Component Compliance						
Possible Solutions:			Comp	Data	Comp	liance	Description		
Remove & Replace Entire	Ram	ıp.	N/A	Ramp Length (in)	48.0	Yes	Ramp	Slope (%)	
			No	Ramp Width (in)	46.5	Yes	Ramp	XSlope (%)	
			N/A	Flare Type LT	N/A	N/A	Flare	Type RT	
			N/A	Flare Slope LT (%)	N/A	N/A	Flare	Slope RT (%)	
4			N/A	Flare Traversable LT?	N/A	N/A	Flare	Traversable RT?	
			N/A	Landing Length (in)	N/A	N/A	DWS	Provided?	
Surveyor Notes:			N/A	Landing Width (in)	N/A	N/A	DWS	Contrast?	
N/A			N/A	Landing Slope (%)	N/A	N/A	DWS	Length (in)	
7			N/A	Landing X Slope (%)	N/A	N/A	DWS	Full Width?	
			N/A	Landing Curb? (Y/N)	N/A	N/A	DWS	Offset (in)	
			N/A	Shared Landing?	N/A				
PROW/ADA:			N/A	Gutter Ponding?	N/A	N/A	Gutte	Slope (%)	
Not Found, R304.5.1			N/A	Gutter Lip Ht (in)	1.0	N/A	Gutte	X Slope (%)	
			N/A	Painted X Walk1?	No	N/A	Painte	ed X Walk2?	
				X Walk 1 Direction	To NW		X Wal	k 2 Direction

N/A	X Walk 1 Width (in)	N/A	N/A	X Wal	k 2 Width (in)	
				X Walk 1 Slope (%)	2.4		X Wal	k 2 Slope (%)	
				X Walk 1 X Slope (%)	4.2		X Wal	k 2 X Slope (%)	
			N/A	Ramp inside XWalk1?	N/A	N/A	Ramp	inside XWalk2?	
				Road Slope (%)	N/A	N/A	Clear	Space?	
				Road X Slope (%)	N/A	N/A	Clear	Space to XWalk (in)	
			N/A	Any Obstructions?	N/A	N/A	Storm	Grate/Utility Hazard?	
Total Cost:	\$	1850.00		Obstruction Type			Storm	Grate/Utility Type
